**City Project No. 16-936**

**Yellowbird Street Improvements  
Bald Eagle Drive to N. Collier Boulevard  
City of Marco Island, Florida**

**Pavement Survey Findings and  
Recommendations**

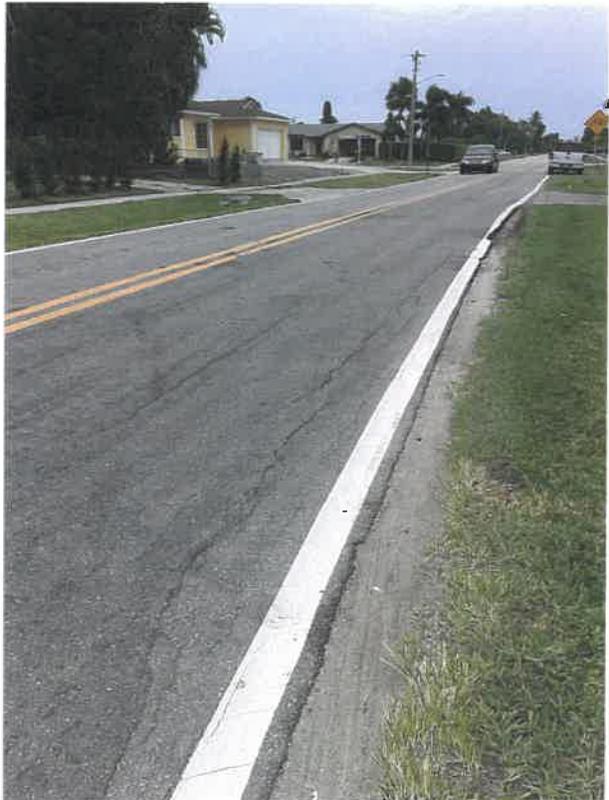
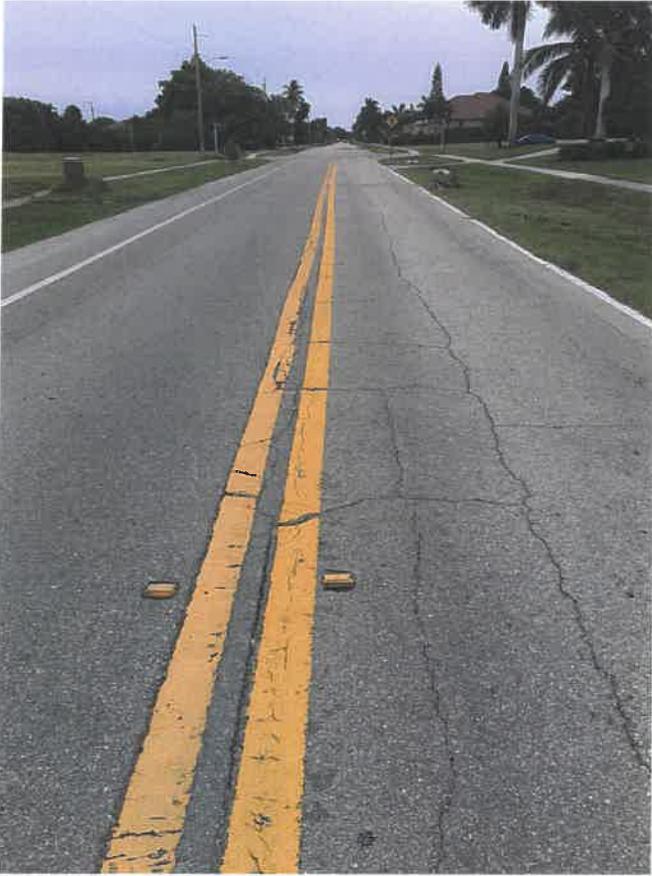
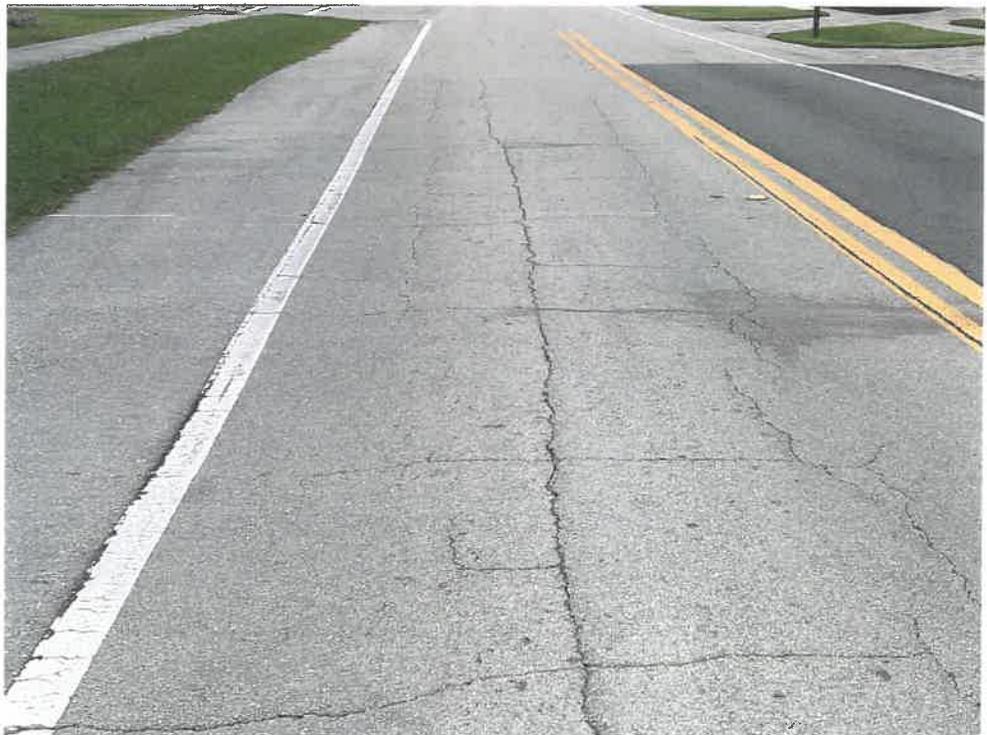
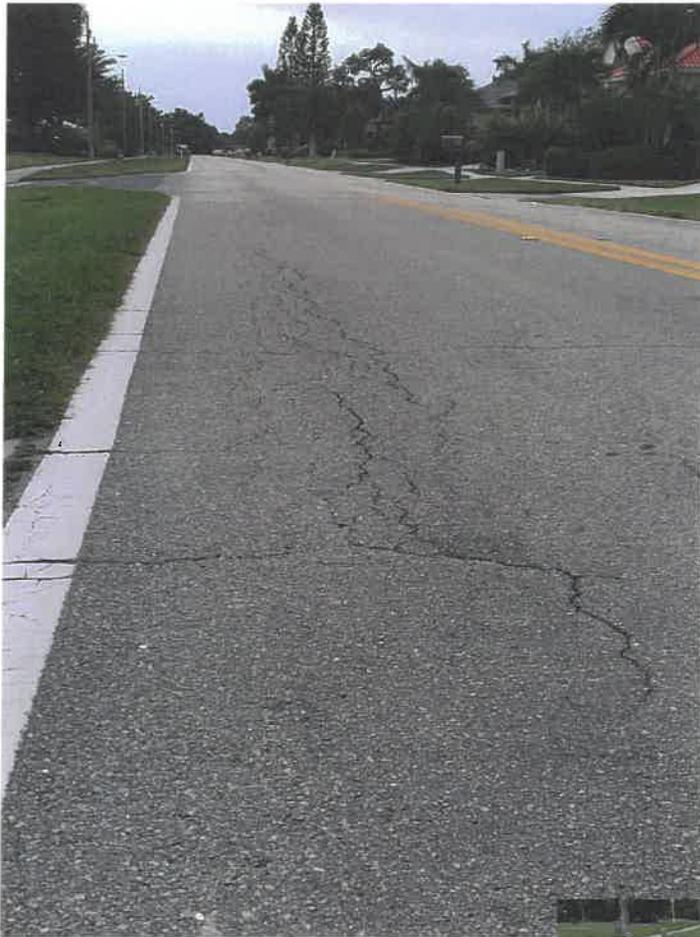
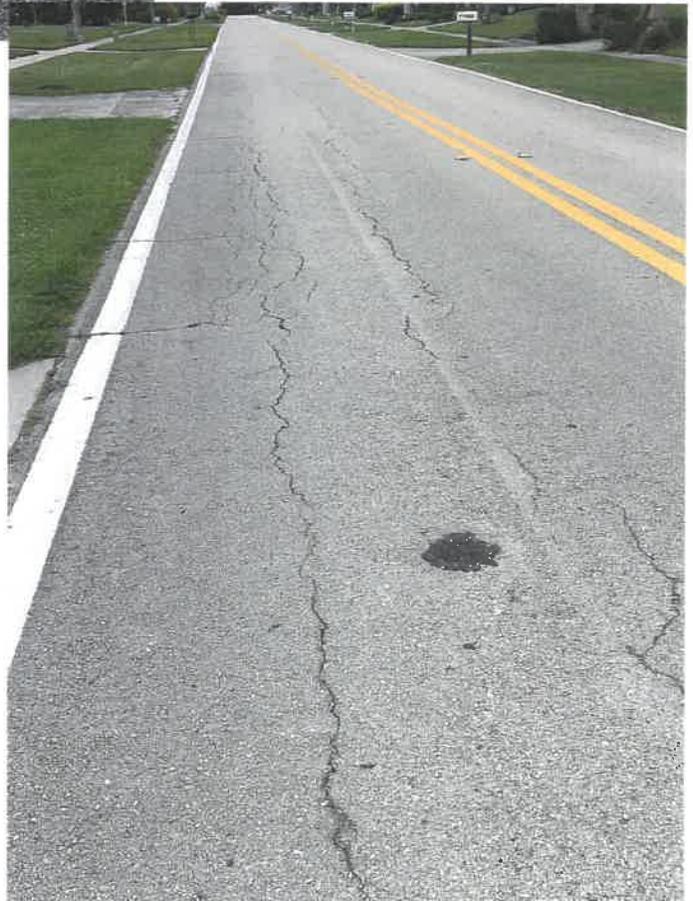
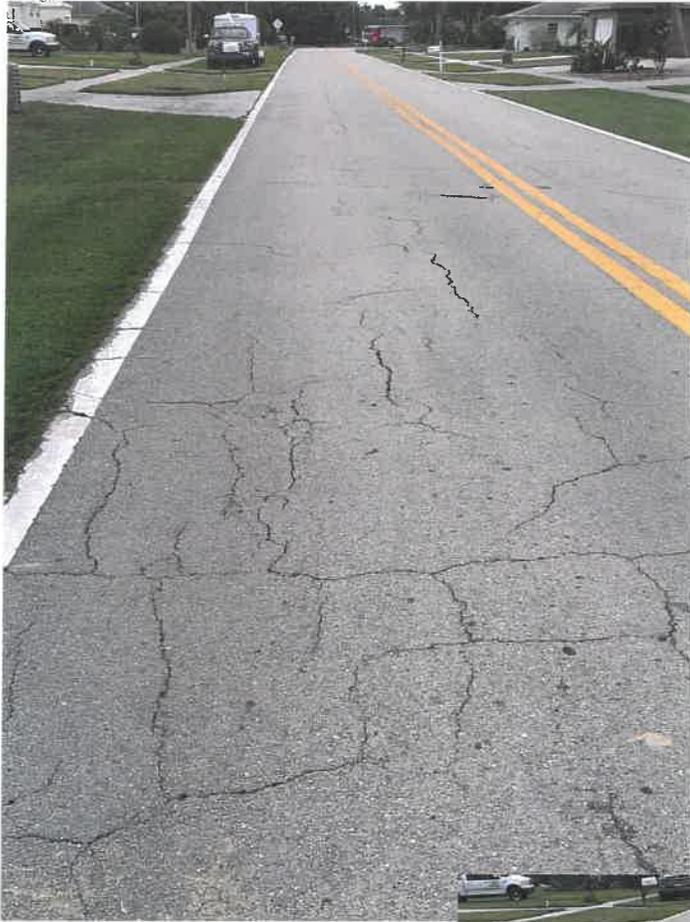
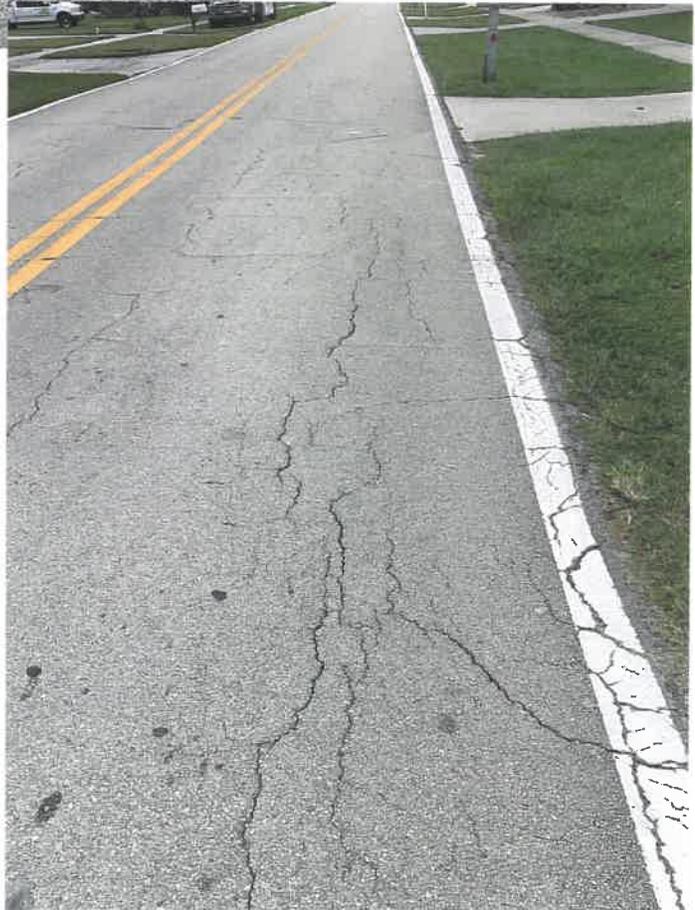
*Fatigue, Block and Longitudinal cracking* – Along much of the roadway there was evidence of fatigue, block and longitudinal cracking, both in and out of the wheel path. Some of the cracking should be labeled as moderate to high in severity. The following pictures reflect areas along the length of the roadway. The failures are not limited to one isolated area but are widespread. In reviewing the geotechnical report it appears that the base material is non-existent in several areas along the roadway. This is contributing to the pavement distress shown in the pictures.

Overall the pavement is in poor to fair condition with extensive cracking, rutting and some drop-offs. As the geotechnical investigation found little to no base material on several of the core samples and since the general use of this roadway is more intense than neighborhood residential uses, it is recommended that the roadway be rebuilt with an adequate pavement section to support the current loadings. Milling and resurfacing with a Marshall Mix asphalt would not provide the structural stability necessary to support the current loading of the road in the long term.

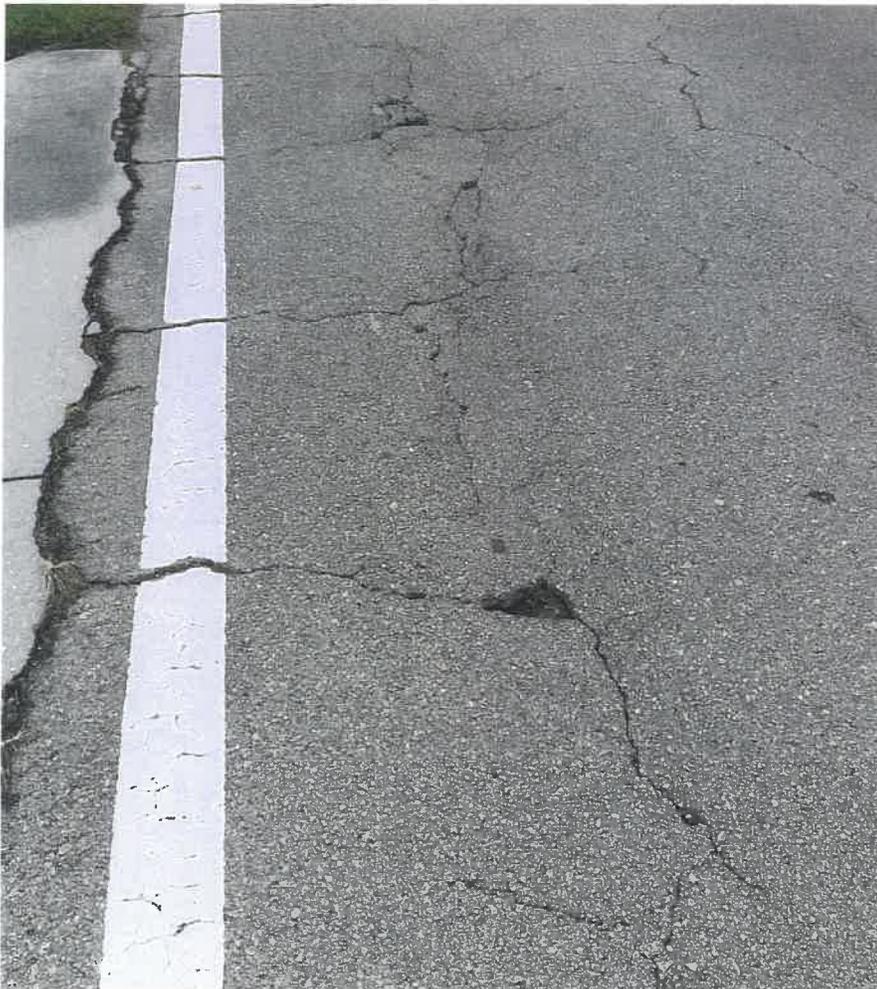
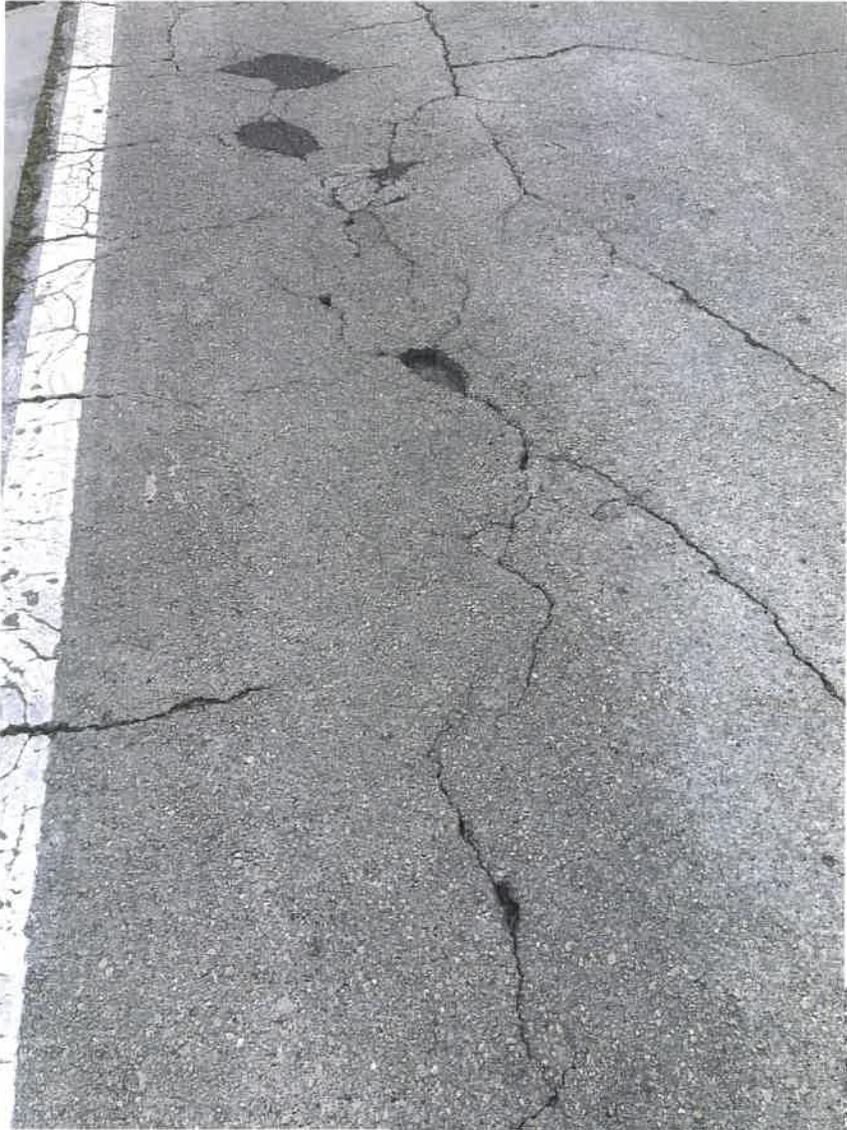
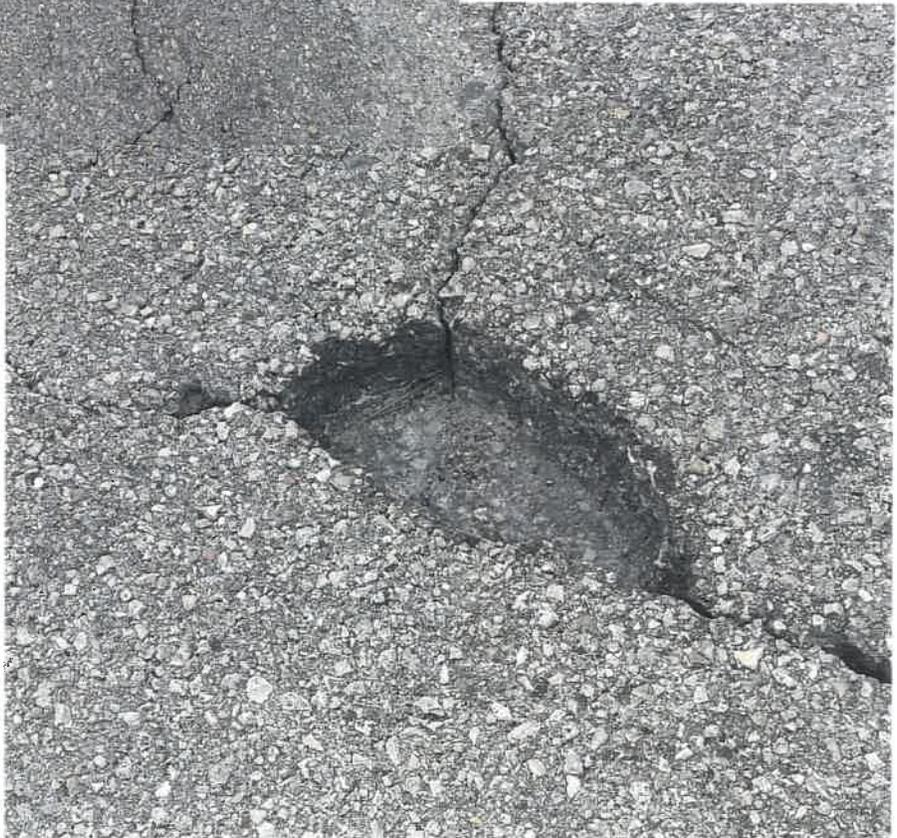
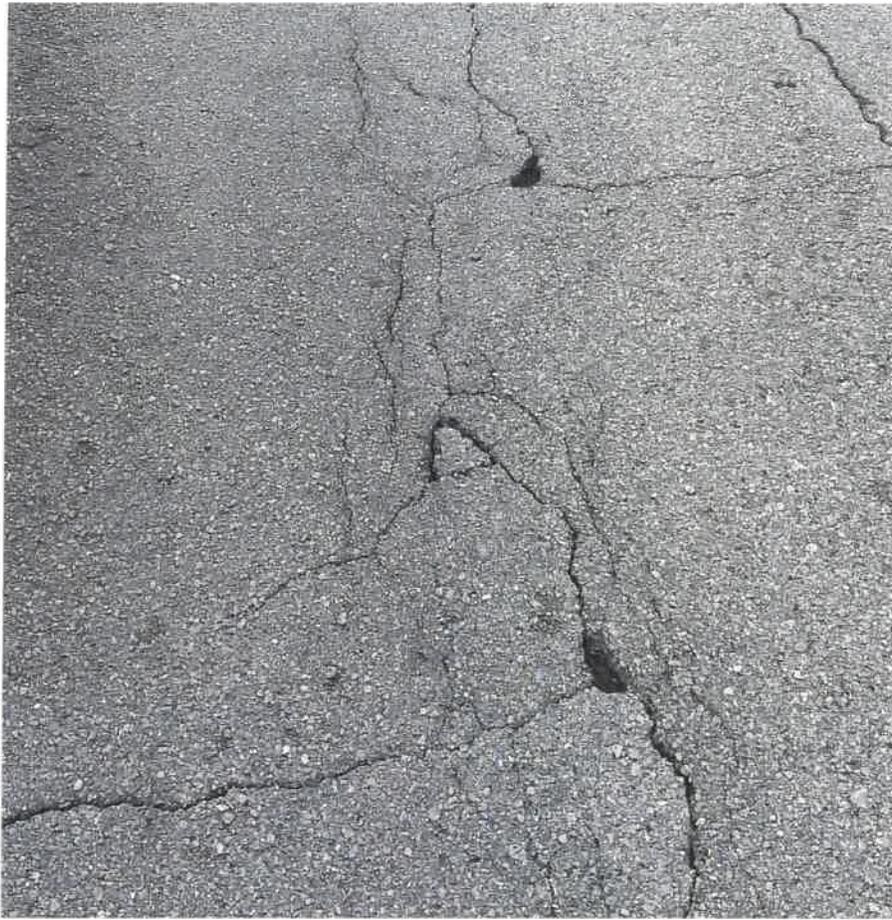
Within the areas exhibiting severe cracking, there were several patches and spot repairs that had been made and a couple of places in need of patching. In a couple of locations, there are chunks of asphalt that have delaminated and are simply sitting in the hole without being bonded to the layer below. These failures allow for water intrusion into the underlying layers of asphalt which further degrades the pavement section.

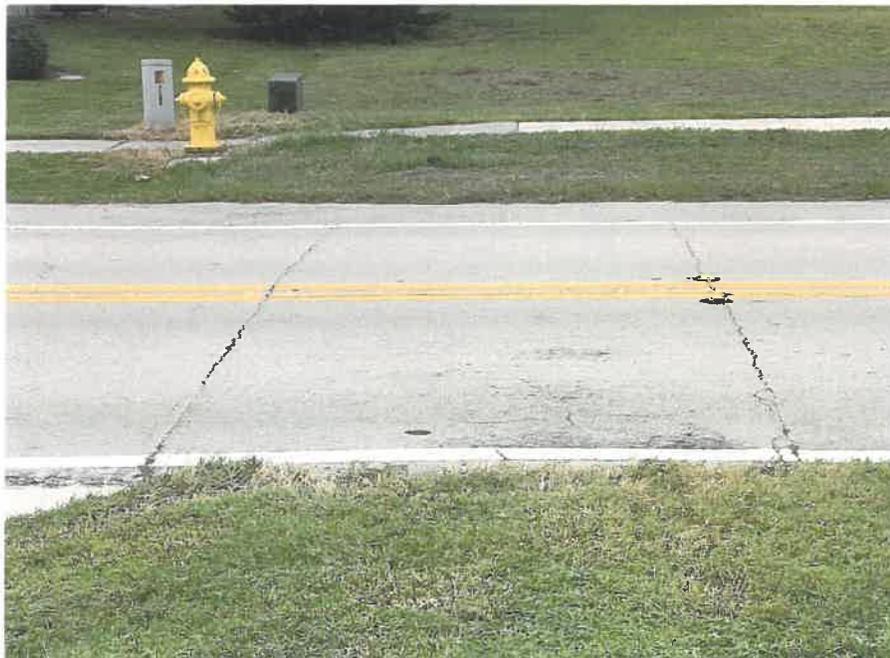
***Reflective cracking*** – In several areas reflective cracking was noted. These areas appear to be in locations where past utility work was completed and there may have been restoration of a trench crossing.

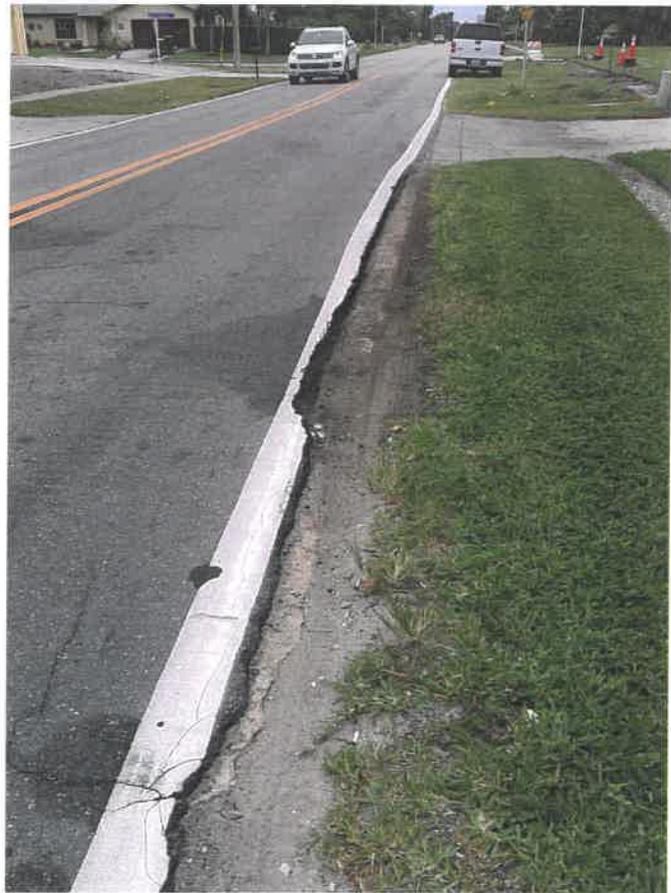
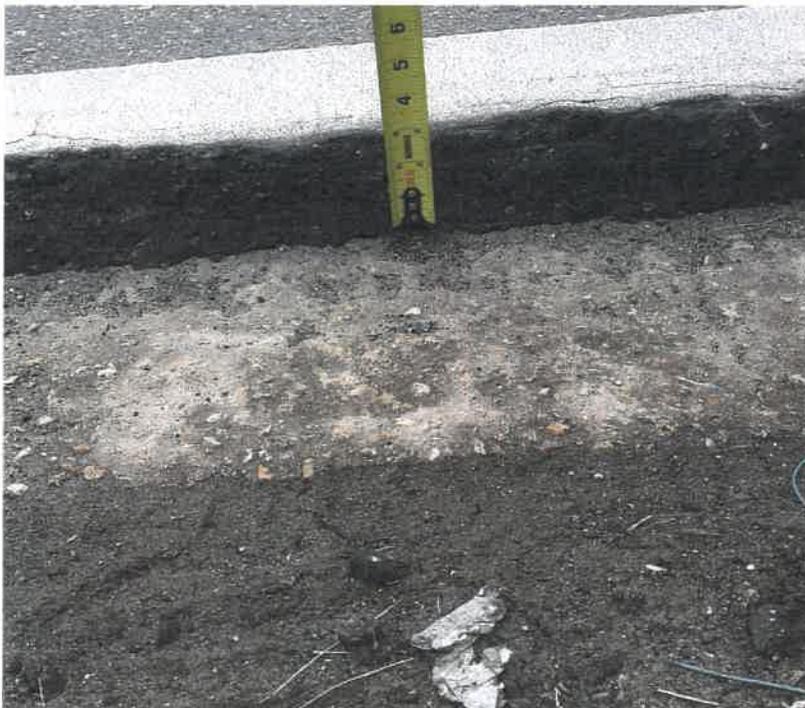
*Lane to shoulder drop off* – At the north end of Yellowbird Street, in the last block before North Collier Boulevard, it was noted that the west shoulder had a significant drop off from the travel lane. This drop off was measured at 3 inches. Due to this drop off, the pavement at the edge line was starting to deteriorate and break off. What appears to be a layer of shell asphalt was visible underneath the asphalt pavement as seen in the photos. This layer of shell asphalt was noted in several of the pavement cores that were taken along the roadway.

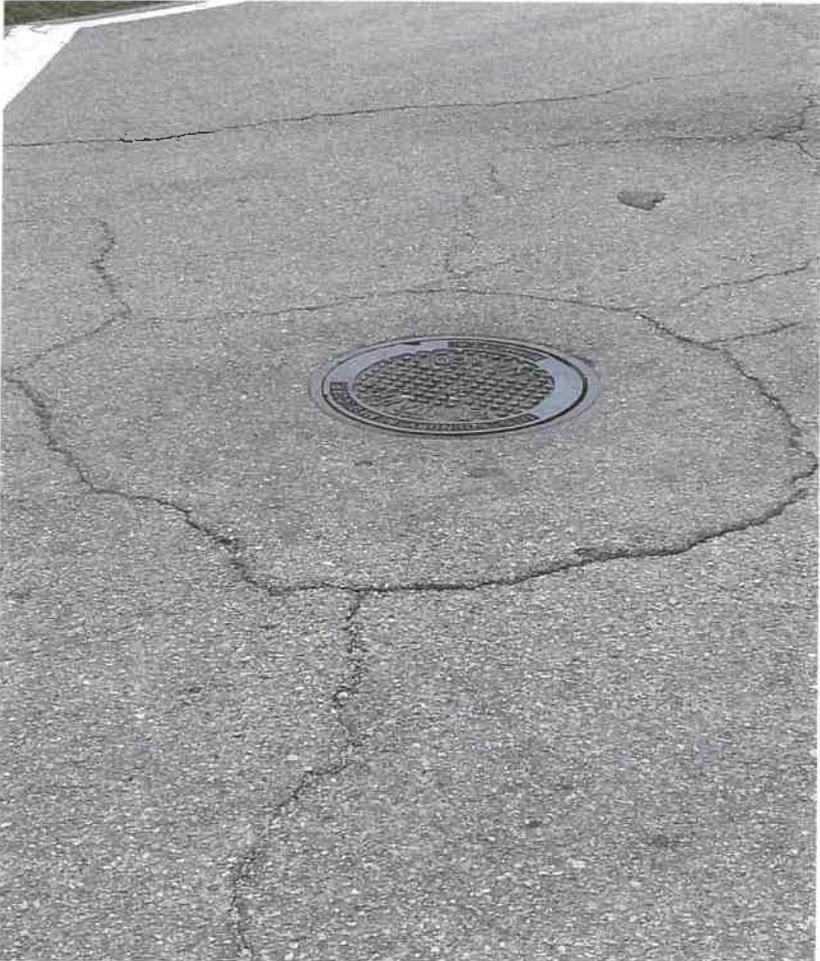
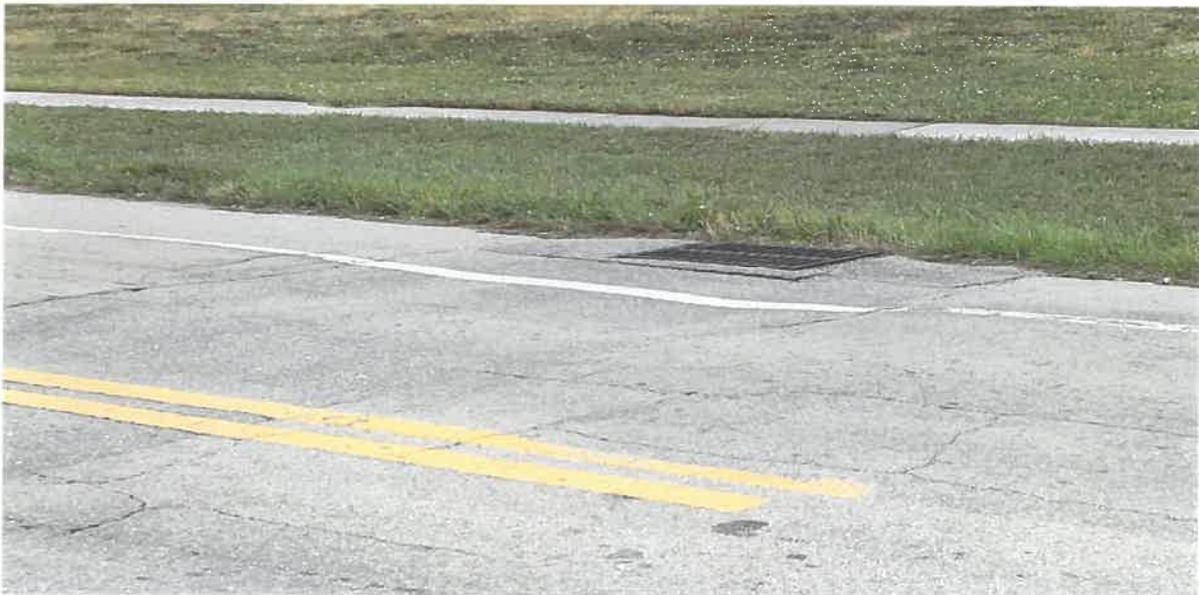
*Uneven Settling around manholes and drainage structures* – Many times when precast structures are installed in pavement areas, compaction around the structure is hard to obtain and subsequent uneven settling occurs over time. This can cause dips or cracking in the vicinity of the structure. This problem was noted in several areas along Yellowbird Street as evidenced in the following photos.

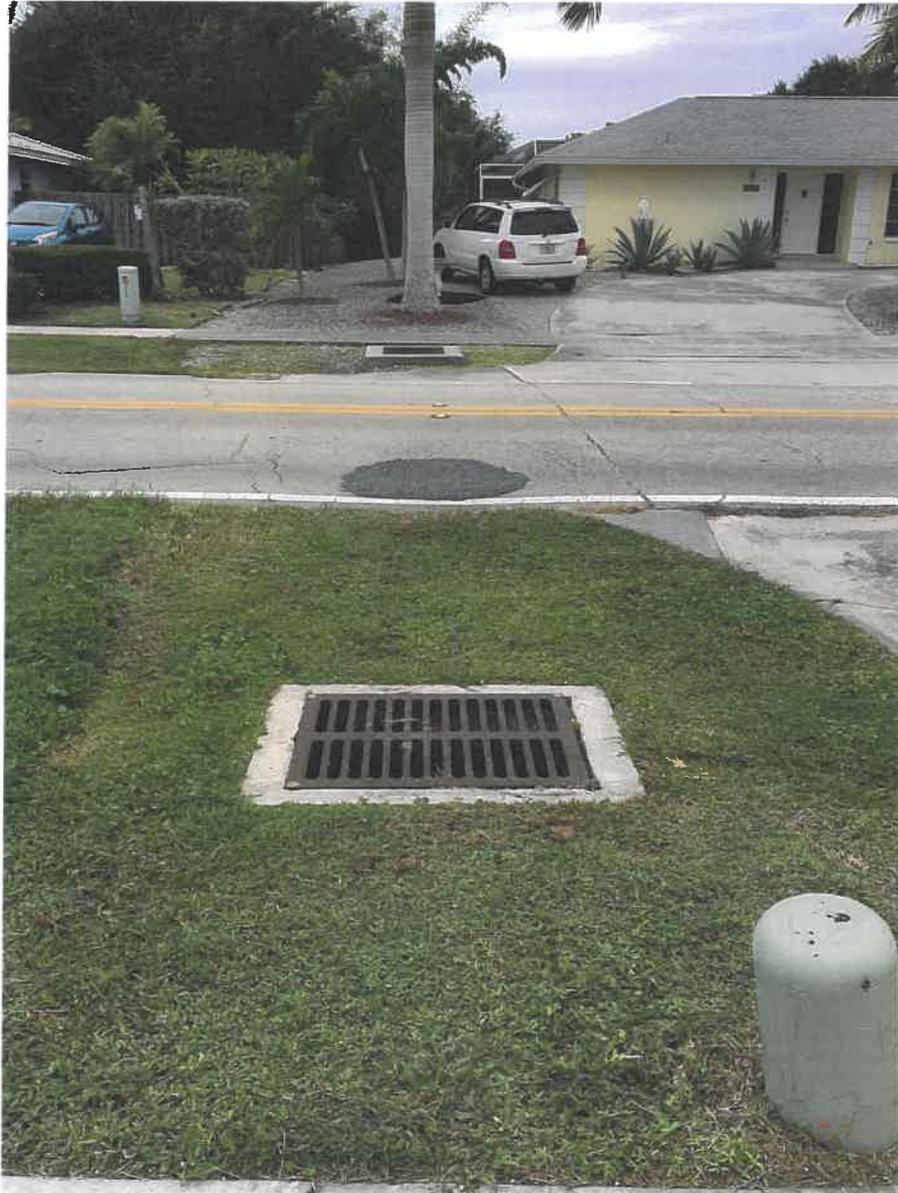
*Pipe crossing* – In the vicinity of 543/553 Yellowbird Street, there is a patch on the roadway that has been placed since March 2015. The patch appears to be the result of a pothole/sinkhole in the travel lane. From our observations, the pipe crossing Yellowbird Street is a CMP that may have failed or have a breach and caused a sinkhole in the travel lane. It is recommended that this pipe be replaced as part of the proposed roadwork. If additional CMPs exist under the roadway, it is recommended that they also be replaced.
