MEMORANDUM

SUBJECT: Hideaway Beach T-Groin Inspection Letter Report

CEC FILE NO. 25.320

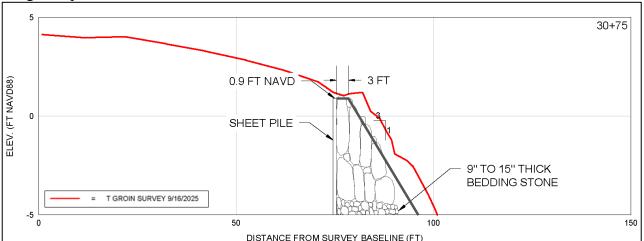
Figure 7. T-Groin 3 Typical Section

- Good: New or good condition
- Fair: Performing the function for which it was intended but is in need of minor repair or maintenance
- Poor: Performing the function for which it was intended but is in need of significant repairs Presented in Figures 7 and 8 are typical T-groin sections depicting the existing condition versus the design templates.

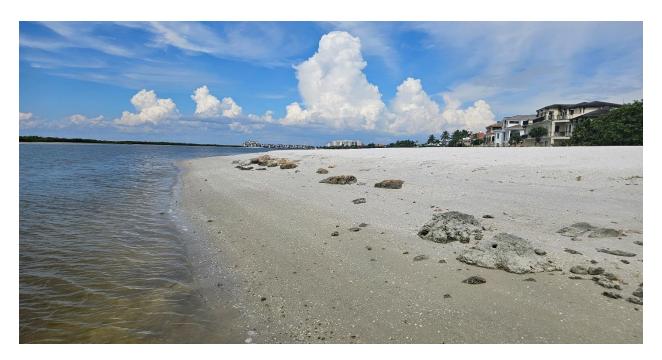
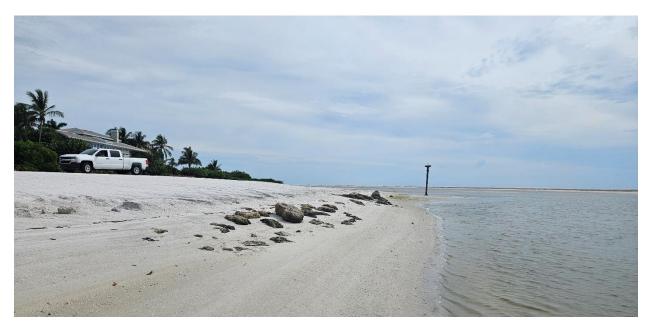
T-Groin No.	Beach Segment	Rating
1	South Point	Buried
2	South Point	Buried
3	South Point	Good
4	South Point	Good
5	South Point	Partially Buried
6	Central Beach	Good
7	Central Beach	Partially Buried
8	Central Beach	Buried
9	Central Beach	Buried
10	Central Beach	Partially Buried
11	Central Beach	Good
12	Royal Marco Point	Good
13	Royal Marco Point	Good
14	Royal Marco Point	Good
15	Royal Marco Point	Good
16	Royal Marco Point	Good
17	North Beach	Good
18	North Beach	Good
19	North Beach	Good

Photo 1: T-Groin 1 facing Northeast

Photo 2: T-Groin 1 facing Southwest

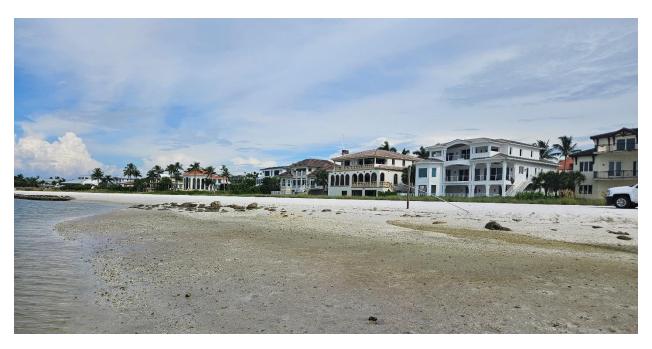
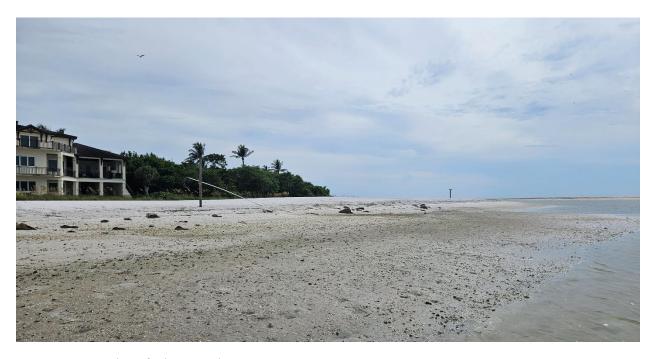
Photo 3: T-Groin 2 facing Northeast

Photo 4: T-Groin 2 facing Southwest

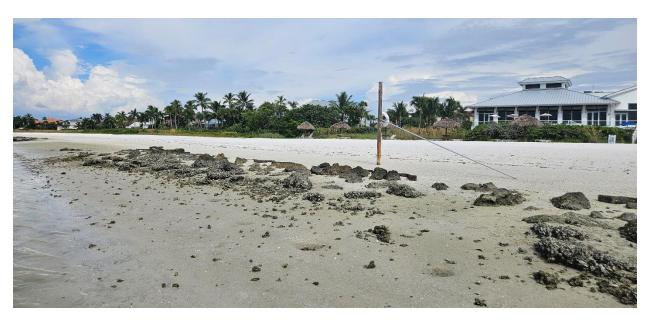
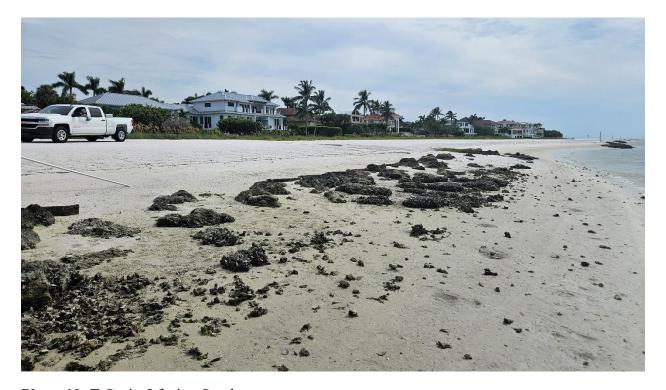
Photo 9: T-Groin 5 facing Northeast

Photo 10: T-Groin 5 facing Southwest

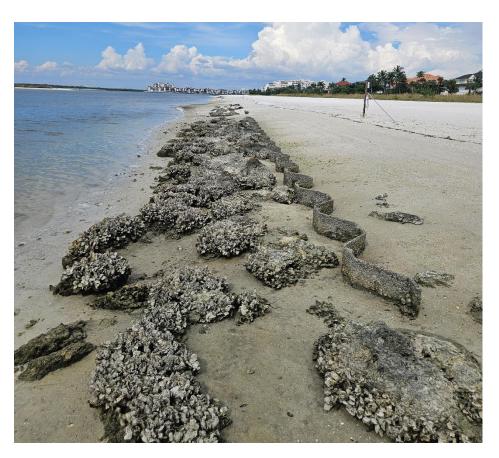
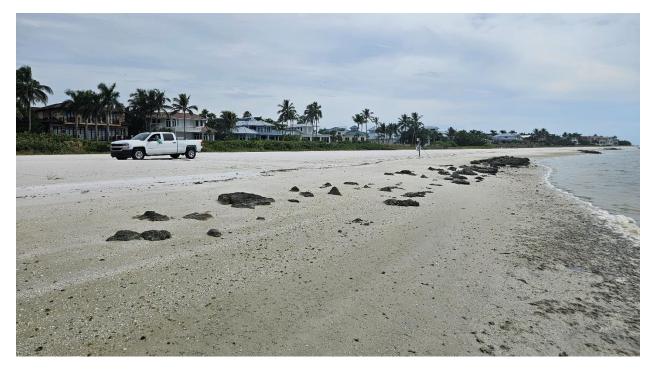
Photo 13: T-Groin 7 facing Northeast

Photo 14: T-Groin 7 facing Southwest

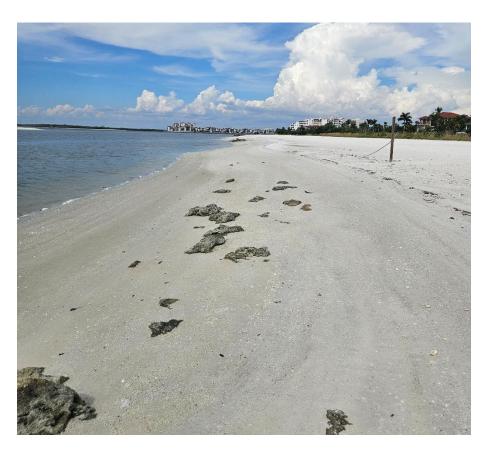
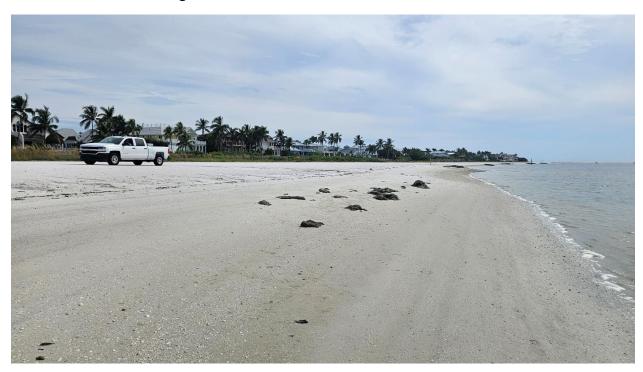
Photo 15: T-Groin 8 facing Northeast

Photo 16: T-Groin 8 facing Southwest

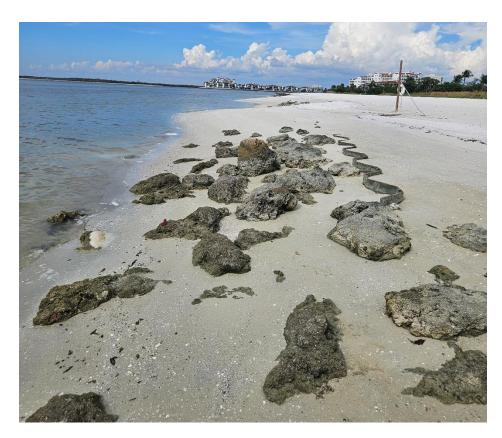
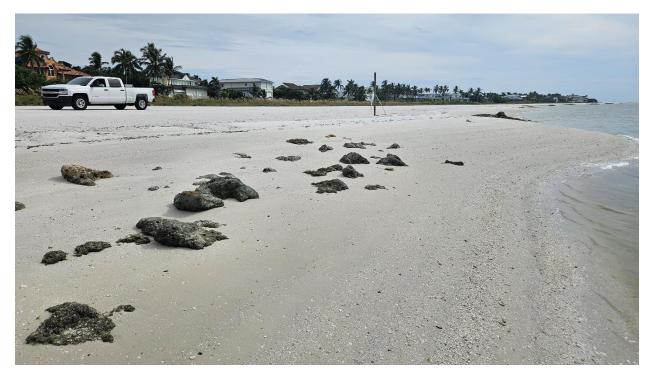
Photo 17: T-Groin 9 facing Northeast

Photo 18: T-Groin 9 facing Southwest

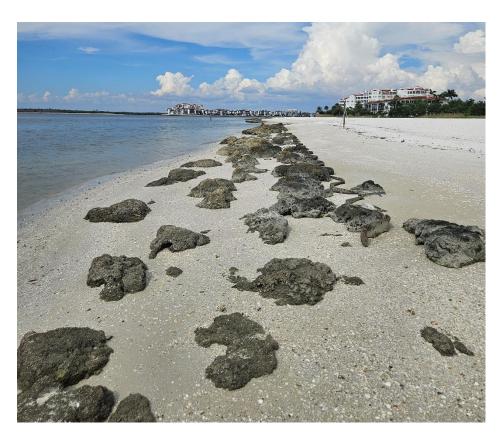
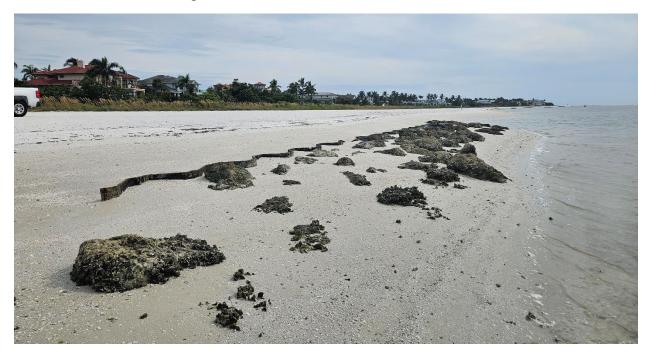
Photo 19: T-Groin 10 facing Northeast

Photo 20: T-Groin 10 facing Southwest

The District may consider implementing the minor repairs to T-Groin 10 through T-Groin 16 due to their direct exposure in conjunction with a future O&M project on Hideaway Beach to take advantage of a mobilized contractor to realize cost savings and reduce impacts to the beach.

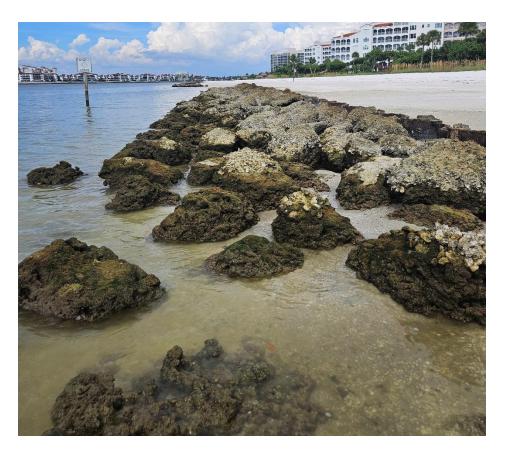
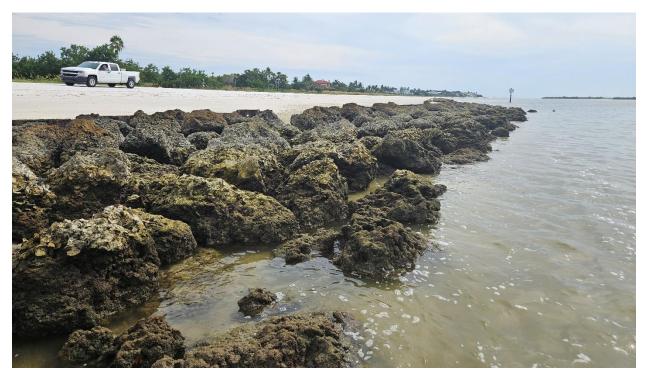
CEC located the existing signage marking several T-Goins. They were installed as part of the 2005 and 2010 projects. The original intent was to advise boaters and beach-users of newly placed rock along the beach and nearshore. The 2013 project did not include any signage. Only two signs remain and they are located at T-Groin 12 and T-Groin 16.

Of particular note, T-Groin 12 and T-Groin 16 were constructed in 2005. The design template for their end segments were bolstered as there were no neighboring structures. Excluding these end segments due to presence of the adjacent T-Groins constructed in 2010 and 2013, the repair tonnage drops to 300 tons.

Photo 23: T-Groin 12 facing Northeast

Photo 24: T-Groin 12 facing Southwest

Considering the age of the T-Groins, minor amount of damage recorded by the inspection, and continued successful beach fill performance along Hideaway Beach despite the significant hurricanes that have impacted the Project Area over the past several years, at this time, the recommendation is to continue to monitor the structures. One of the signs on T-Groin 12 is upside down and should be fixed.

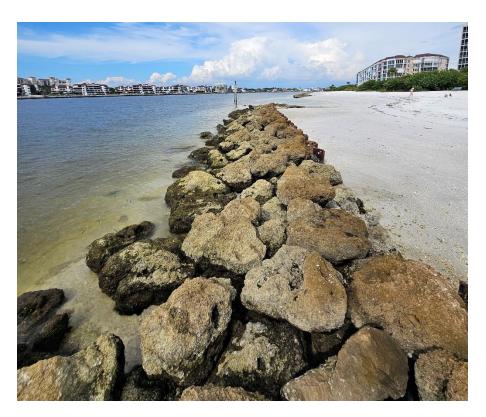
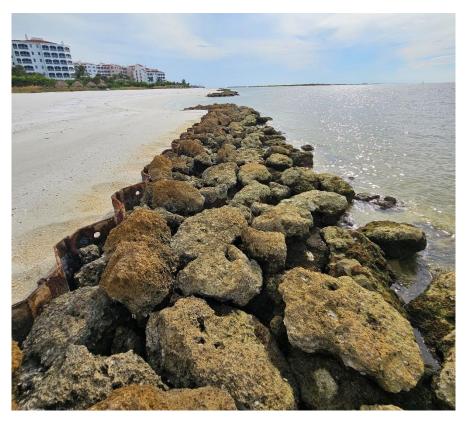
Photo 30: T-Groin 16 facing Northeast

Photo 31: T-Groin 16 facing Southwest
