**TIGERTAIL LAGOON/ SAND DOLLAR ISLAND
ECOSYSTEM RESTORATION PROJECT
POST-CONSTRUCTION
BIOLOGICAL MONITORING REPORT 3- 2025**

**SECTIONS 6 & 7, TOWNSHIP 52 SOUTH, RANGE 26 EAST
COLLIER COUNTY, FLORIDA**

MARCH 1, 2025

**DEP PERMIT NO. 0401778-001-JC
USACE PERMIT NO. SAJ-2007-04224 (SP-SJF)**

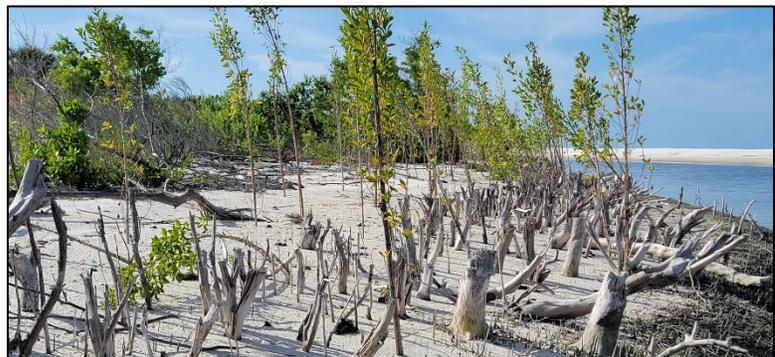
Figure 3: Buttonwood shoreline plantings

Shoreline planting in Zones 2 and 3 was hindered by a very dense old mangrove root system which proved more than once to be impenetrable with a gas-powered auger. As a result, plantings on the shoreline were installed as deep as physically able. Additionally, these shorelines are no longer at a tide elevation needed for red mangrove growth due to sand encroachment even though we lowered them somewhat when cleaning out dead debris. In order to re-establish more trees along the shoreline for the time being, green buttonwood (*Conocarpus erectus*) were utilized instead of mangrove for their tolerance to elevation changes. Recent high winds in February 2026 (in excess of 50 mph) pushed some of the plantings over so an assessment is upcoming the first week of February at low tide to determine if additional plantings will be suggested. Prior to the nor'easter, survivorship was around 90% (see Figure 2).

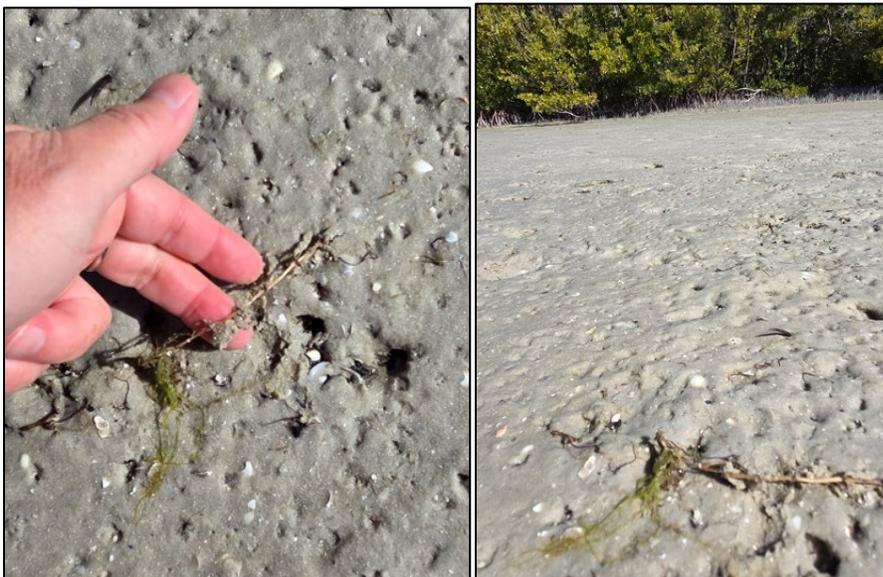
Figure 4: Exposed shoal grass and rhizome on heavy traffic area in lower Zone 3 at low tide

Zone 3: Zone 3, which was historically the most dense and persistent seagrass area, has experienced the most storm-driven damage of any other segment of the system caused by repeated sand burials and scouring since 2022 from at least five named storm events. The main segment of Zone 3 was fully dredged in 2023 after being totally buried, then again in 2025 after the same issue. Sand has been introduced to the south end of Zone 3 to such a degree that the entire substrate has transitioned from muck to hard packed coarse sand. The elevation of this relatively shallow channel has also increased, resulting in most of the southern channel being exposed at low tide now. This exposure of remaining seagrass beds which have not been totally buried or scoured yet is jeopardizing the SAV health in the harsh August temperatures and as is the case in 2026 so far, to freezing temperatures. Human beachgoing traffic from the park has also become problematic for Zone 3 SAV beds. A recently installed south distribution channel may help with foot traffic issues at least.
