Macro Island Public Beach Access Improvements 2024

Introduction and overview:

Appendix A – Existing Winterberry Drive Corridor Elements

Appendix B: Existing Maple Avenue Corridor Elements

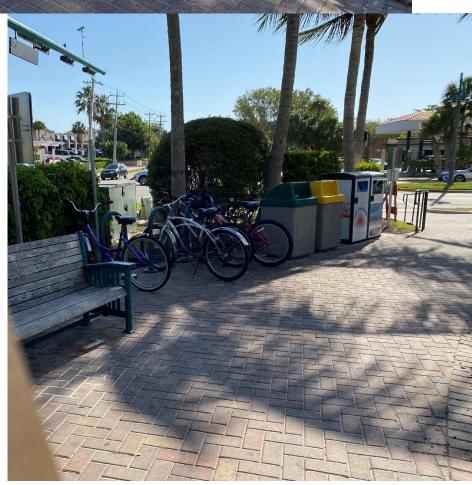
Transition from paver path to boardwalk: The transition space had a bench, a life jacket station, a shower fixture, and trash receptacles. Poor shower station drainage results in sand piles and slippery algae growth.

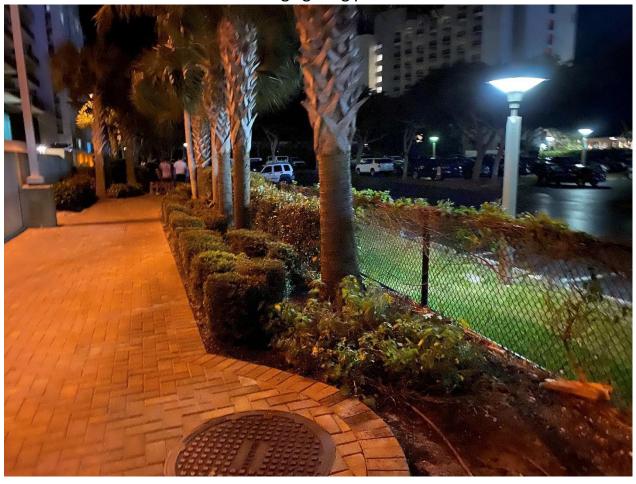
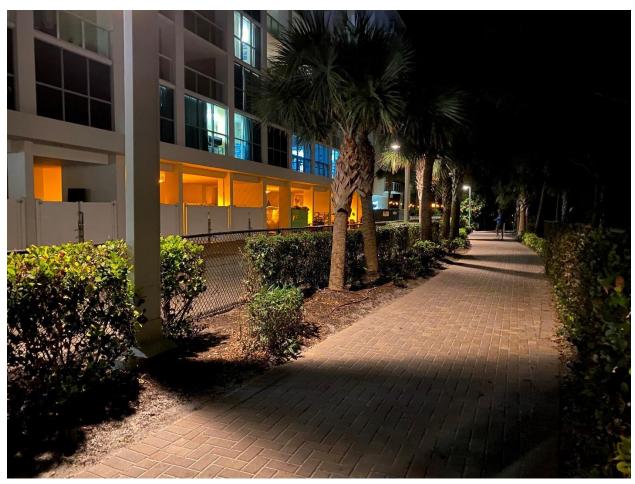
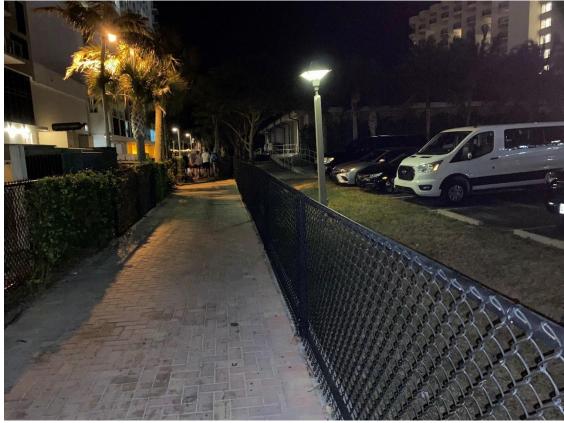
Evening lighting photos

Existing Path lighting consists of 24 low path lights, 11 of which are currently broken and inoperable. On the east half of the path, 4 lights are on the north side and spaced at 15'. The next 5 lights are on the south side of the path spaced at 15'. The remaining lights are staggered on either side of the path spaced 30' per side or 15' on the stagger.

Lights illuminating the south adjacent property driveway also casts light onto the corridor. There are 9 tall driveway lights spaced approximately 40' apart.

There are several lights illuminating the north adjacent parking lot. These lights cast light on the eastern 1/3 of the corridor.

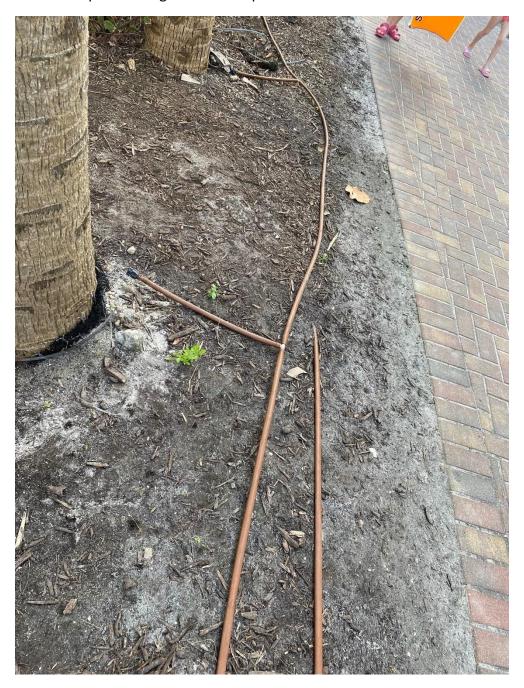
Irrigation is installed but exposed along much of the path.

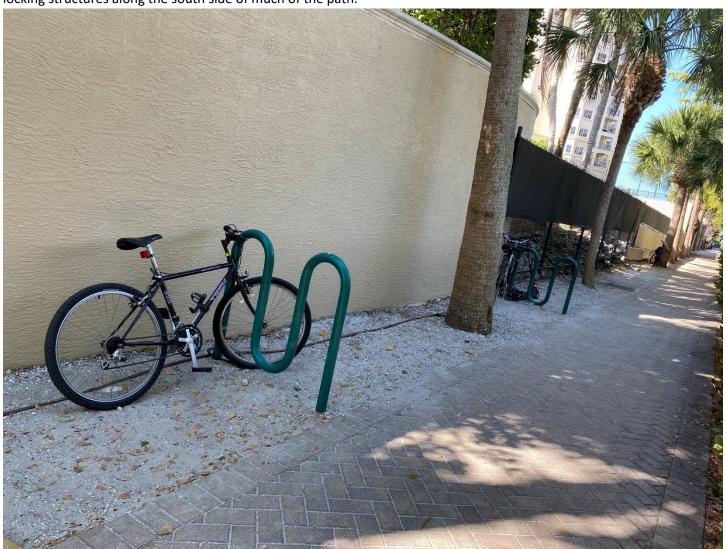
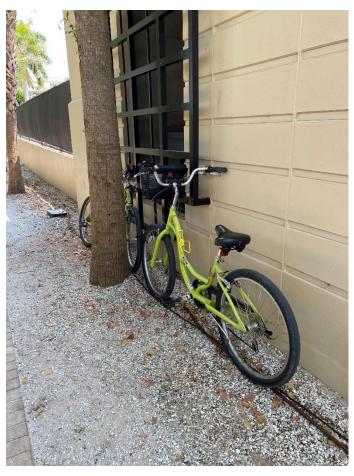
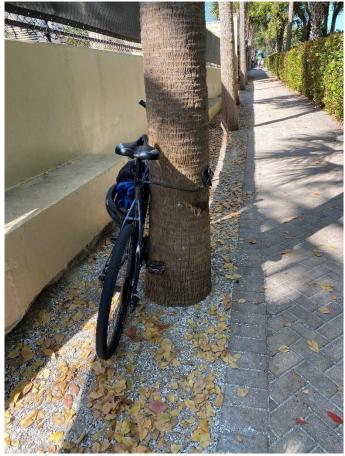
Bicycle racks: There are two existing bike racks just inside the entrance to the corridor along the south wall. Each rack is 4 feet wide and has 6 feet of clearance on both sides for the bicycle frames. These are often full and bicycles are locked to the grids on the garage windows and palm trees further along the path. There is space for sculptural bicycle locking structures along the south side of much of the path.

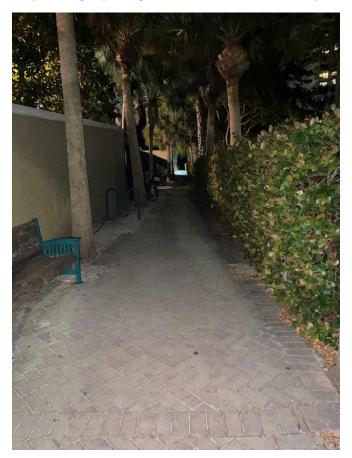
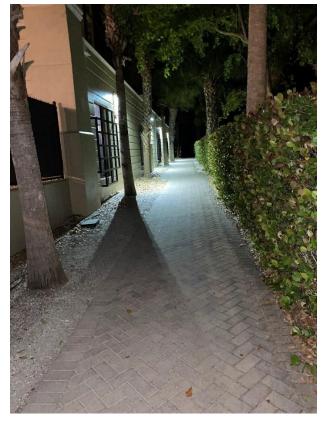
Path lighting: There is no path lighting currently, however, the garage wall has 4 bright lights spaced 30 feet apart. These illuminate that portion of the path brightly at night and the remainder of the path is dark.
