Submerged Resour	ce Survey

899 CAXAMBAS DR. MARCO ISLAND, FL 34145 FOLIO #58106440008

SUBMERGED RESOURCE SURVEY REPORT OCTOBER 2019

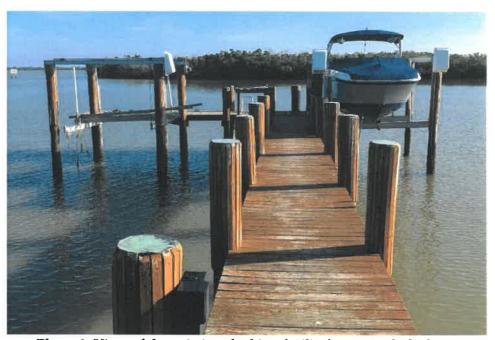
Photo 1: View of the existing docking facility's terminal platform

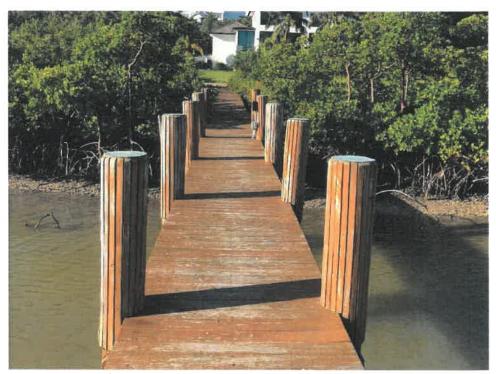
Photo 2: View of access walkway and uplands

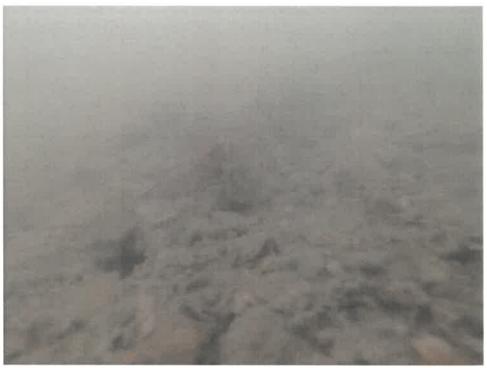
The substrate found within the surveyed area consists of silt and shell debris and rocks. With distance from shore, shell debris and rocks become more sparse. Depths increased gradually with distance from the mangrove shoreline to the limits of the survey from approximately 0 to 9 feet.

Photo 3: Typical view of bottomlands found within the vicinity of the project site.

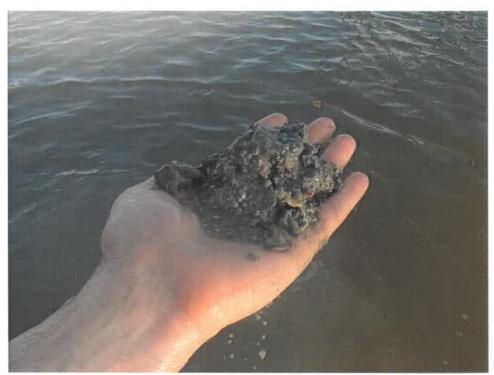
Photo 5: Typical consistency of substrate found on-site
