# WALKER'S CAY

Parcels 78567000342 and 58420200005 3200  
San Marco Road, Marco Island, FL 34145

## ENVIRONMENTAL SUPPLEMENT

September 2025

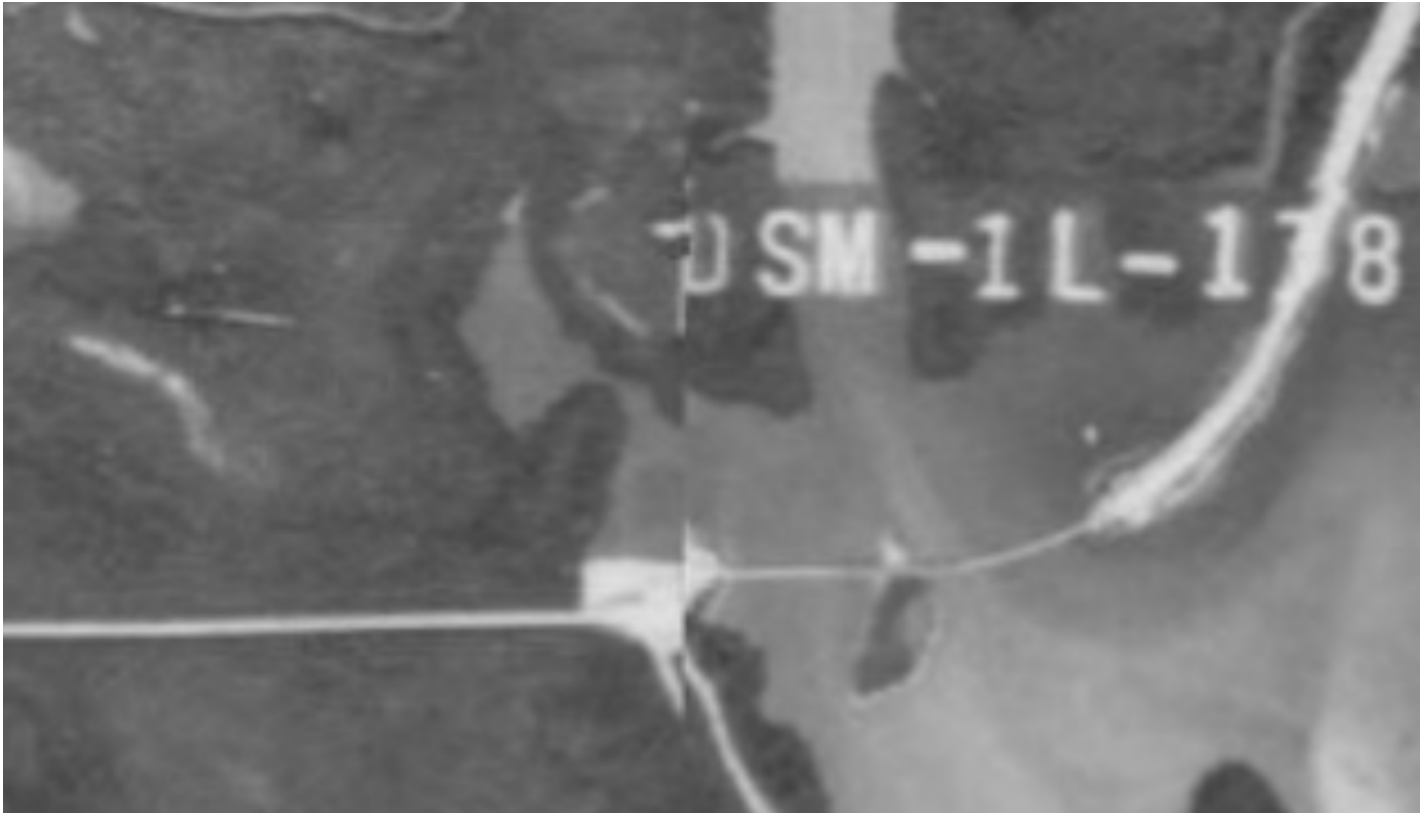
Since the site has been vacated for some time mangroves which were seaward of the fill have encroached slightly in a few locations and are overhanging some of the fill in others. Permanent lateral mangrove trimming authorization along the edge of the parking lot is sought for approximately 0.03 acres with this permit to prevent damage to vehicles as well as authorization for 0.01 acres of direct mangrove impacts to accommodate parking near the entrance. The area of permanent impact proposed is to second growth vegetation on top of fill pad. Figure 1 below documents original clearing limits.

Figure 1: 1953 Site Aerial- 100% Cleared and Filled

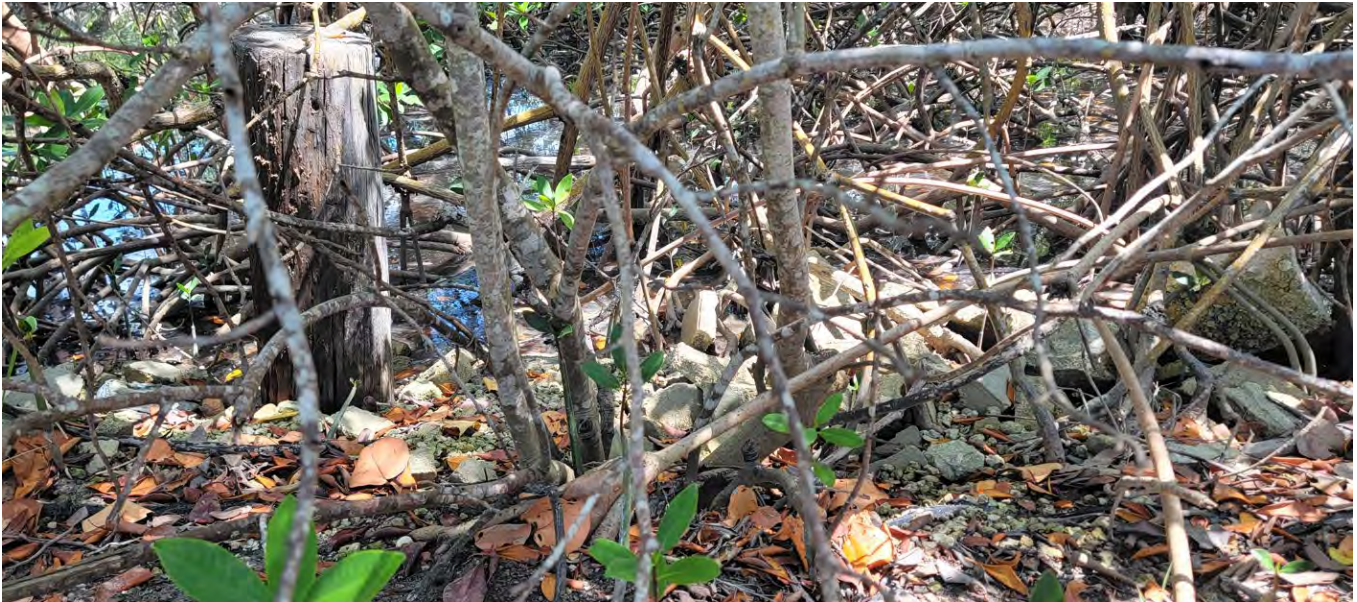
Figure 2: Riprap shoreline. Fill is landward of it and high tide is waterward.

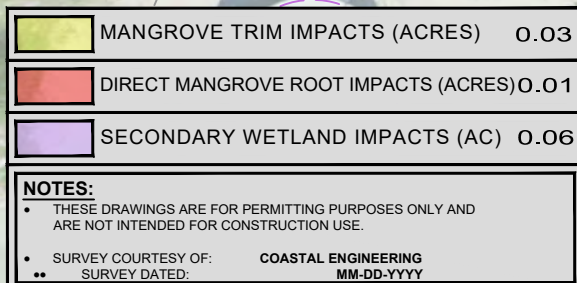
## Impacts Map

**200.5 LF MANGROVE TRIMMING PROPOSED**

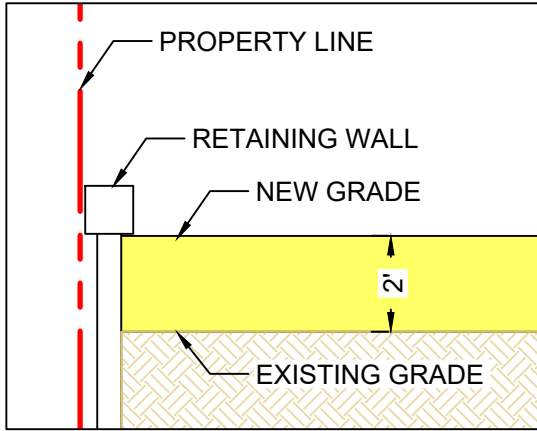
## Fill Map

**FILL AREA DETAIL**  
SCALE: "1" = 4'

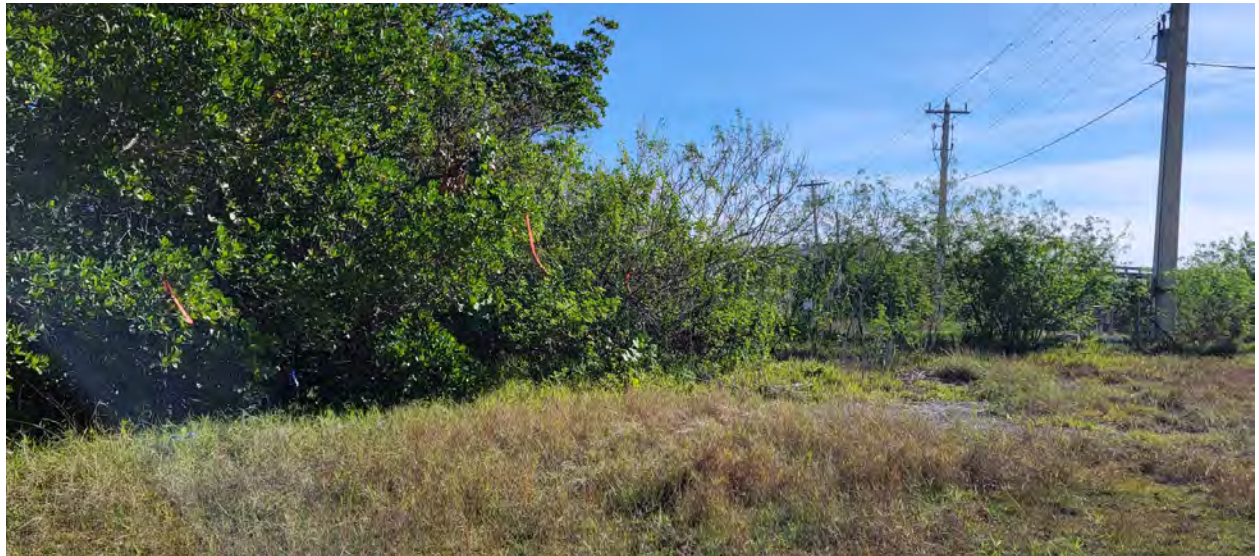
Photo 2: Mangrove and exotic fringe along fill line

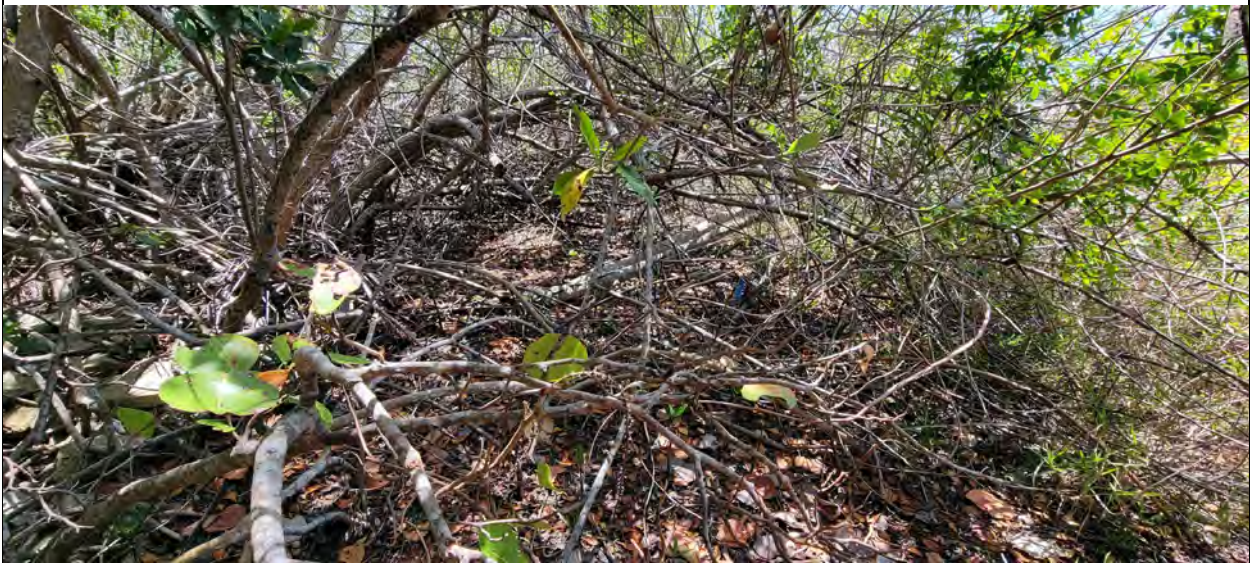
Photo 6: Dense pepper and mangrove on north property line.

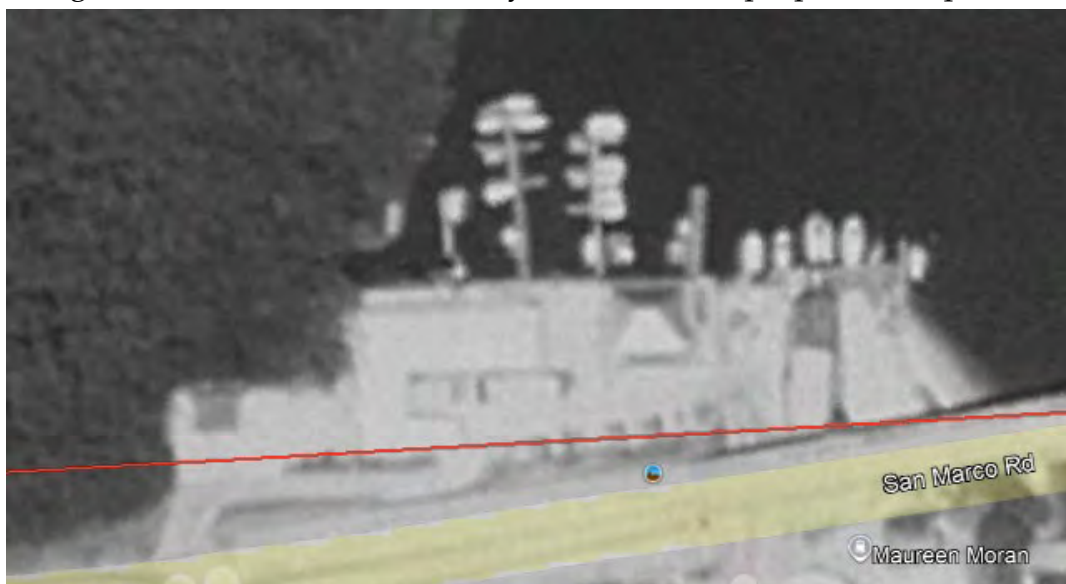
Since the site has been vacated for some time mangroves which were seaward of the fill have encroached slightly in a couple of locations and are overhanging some of the fill in others. Permanent lateral mangrove trimming authorization along the edge of the parking lot is sought for approximately 0.03 acres with this permit to prevent damage to vehicles as well as authorization for 0.01 acres of direct impacts to mangrove roots which have encroached over fill pad and 0.06 acres of secondary impacts to adjacent mangrove habitat. The areas of permanent impact proposed are to second growth vegetation over fill pad and overhanging mangrove. Figure 1 below documents original clearing limits.

Figure 1: 1995 Aerial of site totally cleared within proposed footprint

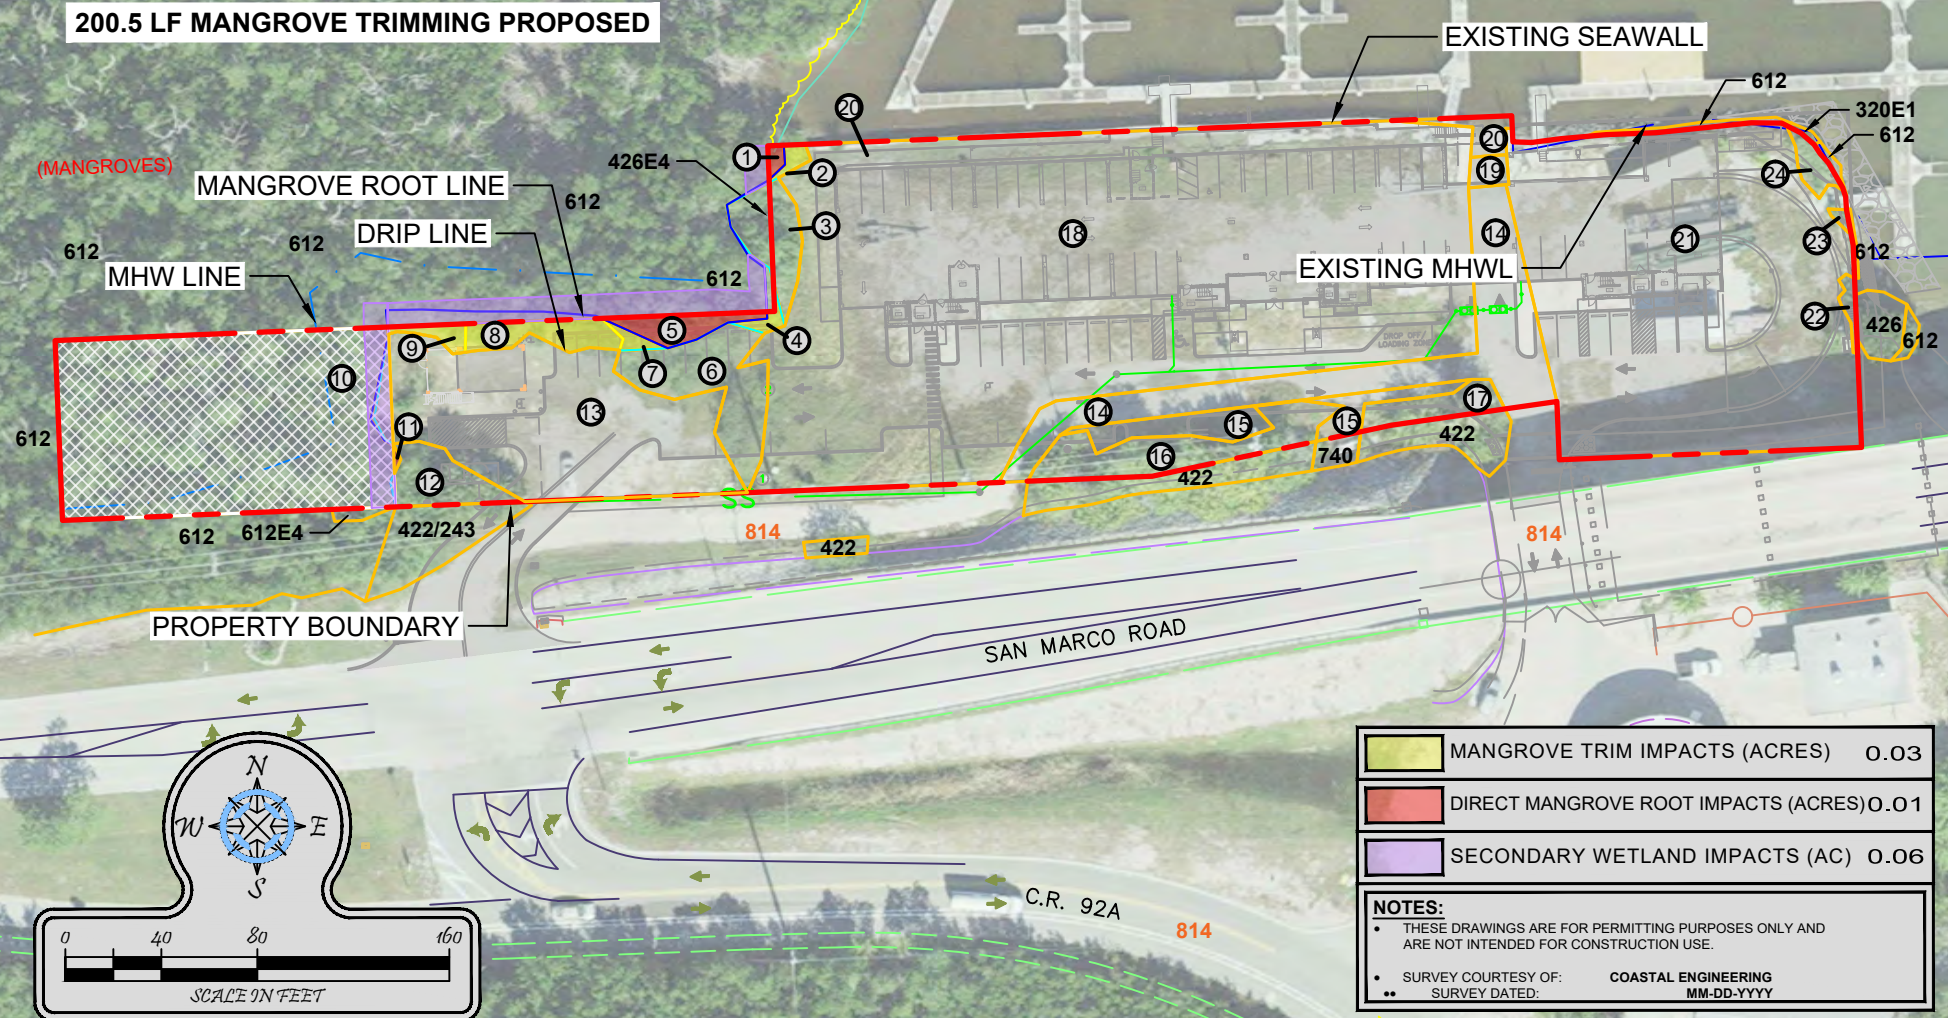
# WALKER'S CAY IMPACTS MAP

## 200.5 LF MANGROVE TRIMMING PROPOSED
