**TIGERTAIL LAGOON/ SAND DOLLAR ISLAND
ECOSYSTEM RESTORATION PROJECT
POST-CONSTRUCTION
BIOLOGICAL MONITORING REPORT 3- 2025**

**SECTIONS 6 & 7, TOWNSHIP 52 SOUTH, RANGE 26 EAST
COLLIER COUNTY, FLORIDA**

MARCH 1, 2025

**DEP PERMIT NO. 0401778-001-JC
USACE PERMIT NO. SAJ-2007-04224 (SP-SJF)**

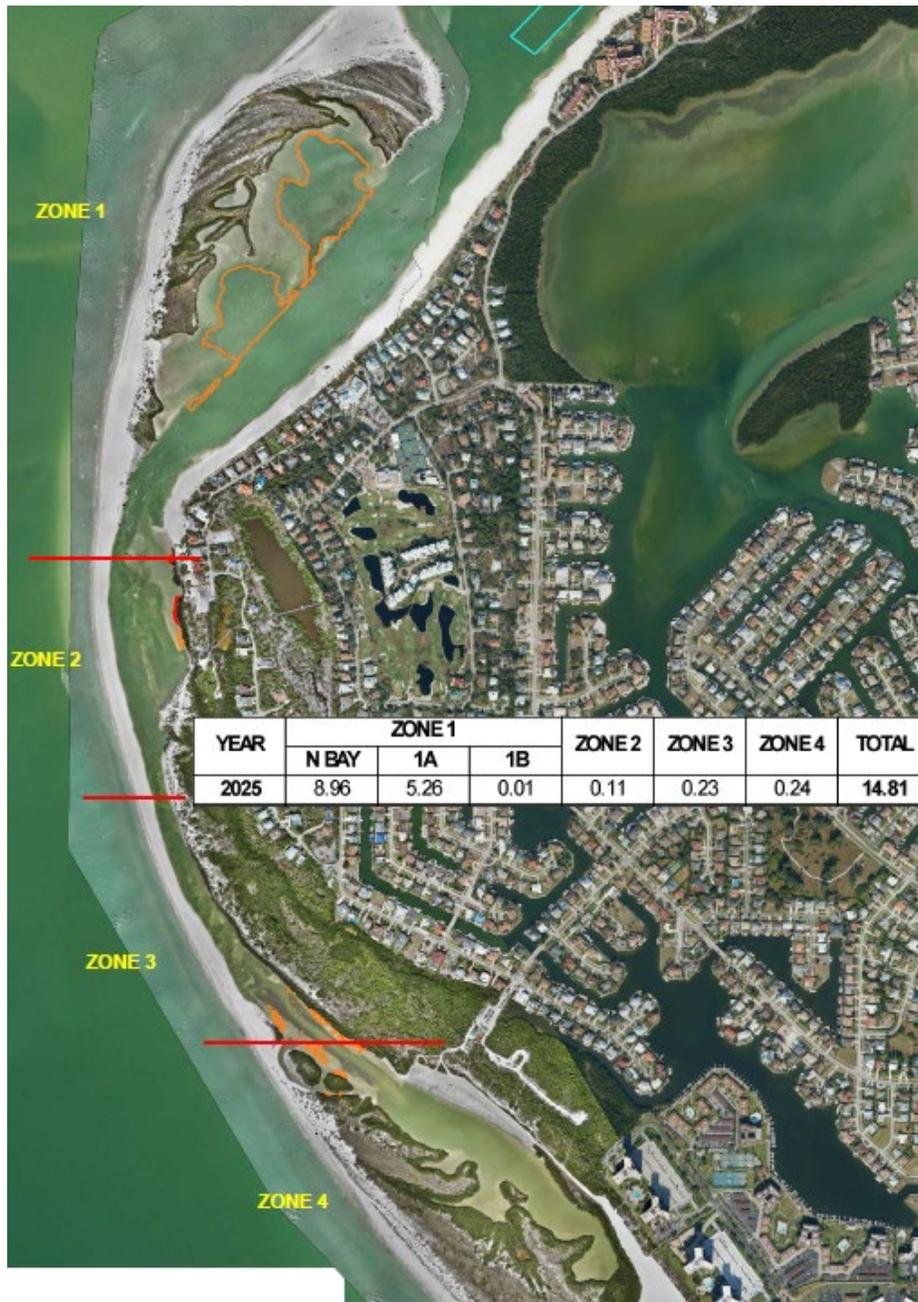
Figure 5: SAV Map of Entire System

Zone 3: Zone 3, which was historically the most dense and persistent seagrass area, has experienced the most storm-driven damage of any other segment of the system caused by repeated sand burials and scouring since 2022 from at least five named storm events. The main segment of Zone 3 was fully dredged in 2023 after being totally buried, then again in 2025 after the same issue. Sand has been introduced to the south end of Zone 3 to such a degree that the entire substrate has transitioned from muck to hard packed coarse sand. The elevation of this relatively shallow channel has also increased, resulting in most of the southern channel being exposed at low tide now. This exposure of remaining seagrass beds which have not been totally buried or scoured yet is jeopardizing the SAV health in the harsh August temperatures and as is the case in 2026 so far, to freezing temperatures. Human beachgoing traffic from the park has also become problematic for Zone 3 SAV beds. A recently installed south distribution channel may help with foot traffic issues at least.

Zone 4 (Transect 34 and Tigertail Lagoon): Only one permanent monitoring transect in Zone exists, which experienced a small (0.08 acre) improvement in overall SAV cover this year. Transect 34 is also subject to the same elevated, exposed and sandy conditions though found immediately north in Zone 3 transects, so these SAV remnants are also in jeopardy. No SAV has been documented since early 2023, but signs of sand accumulation are present in the north bay and western bays and edges. Anthropogenic impacts do occur at the very northern extent of Zone 4 and to minor degrees by fisherman in the southern bay.
