Macro Island Public Beach Access Improvements 2024

Introduction and overview:

Appendix A – Existing Winterberry Drive Corridor Elements

Appendix B: Existing Maple Avenue Corridor Elements

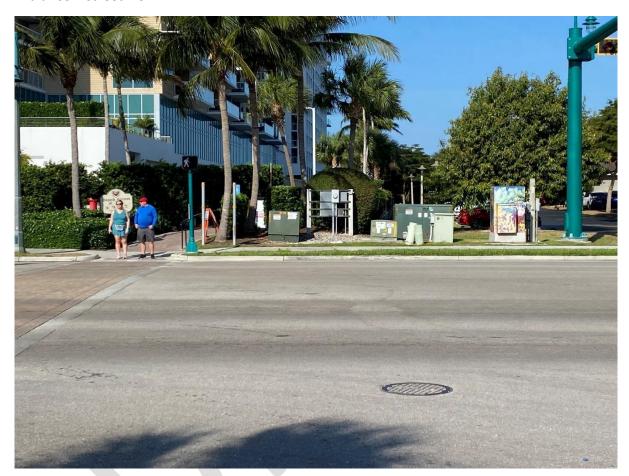
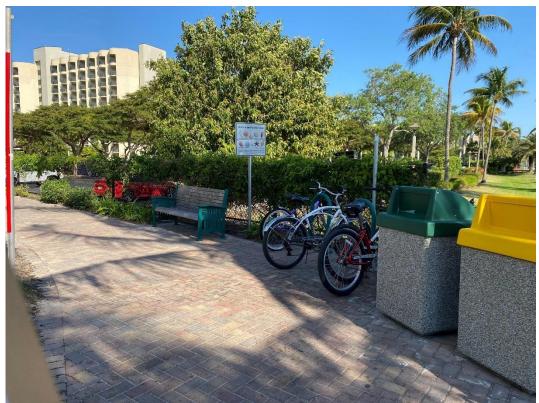
Photo 1: Entrance – street view

Path entry: The path entry has a bench, 3 trash and 1 recycling receptacle, and 1 bicycle rack.

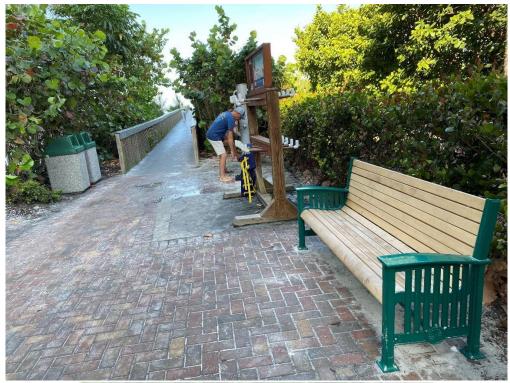
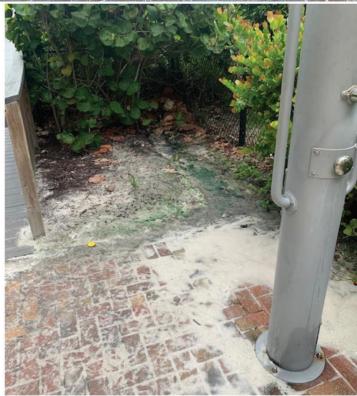
Transition from paver path to boardwalk: The transition space had a bench, a life jacket station, a shower fixture, and trash receptacles. Poor shower station drainage results in sand piles and slippery algae growth.

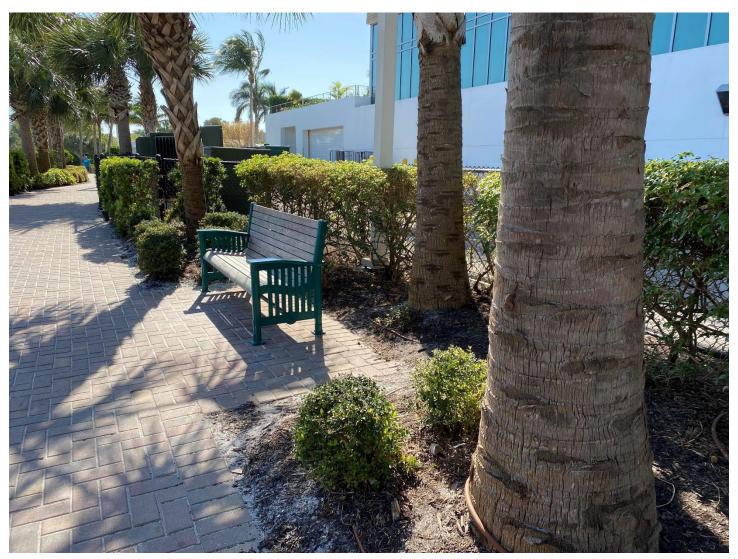
Photo: bench midway along the path

Benches: There are three benches on the path: at the entrance, at the transition to the boardwalk, and midway along the path. All three benches are sturdy and in good condition. The benches will remain in current locations and be power washed when needed.

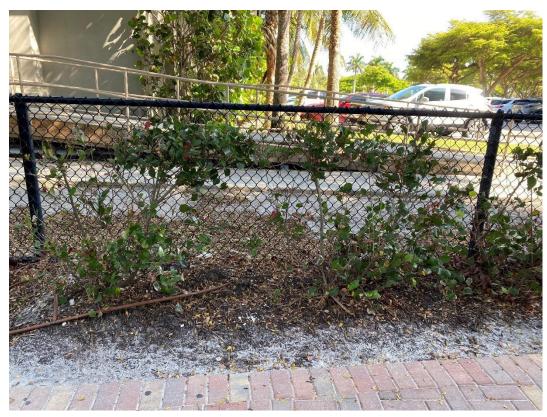
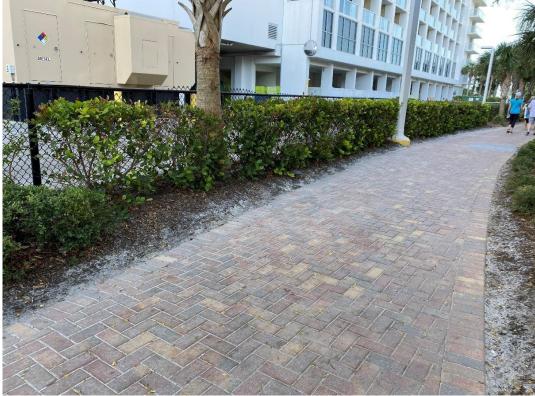
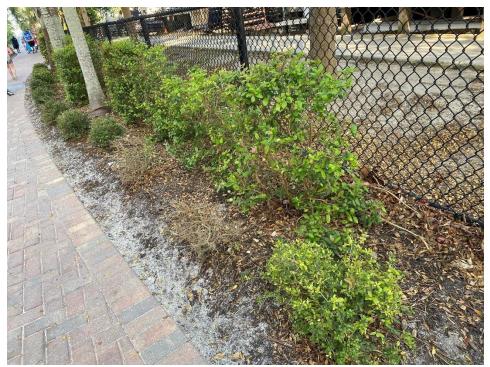
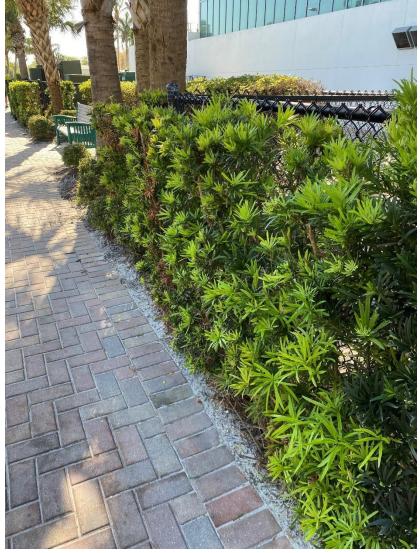
<u>Landscaping/Plants</u>: The vegetation along the Winterberry Drive access path requires replacement and updating. The Maple Avenue access path has standard vegetation along the length of the path. The plans should include appropriate plants as recommended by Naples Botanical Garden and/or IFAS Master Gardener.

Landscaping/Plants: There are several varieties of existing hedge shrubs along the fence and wall.

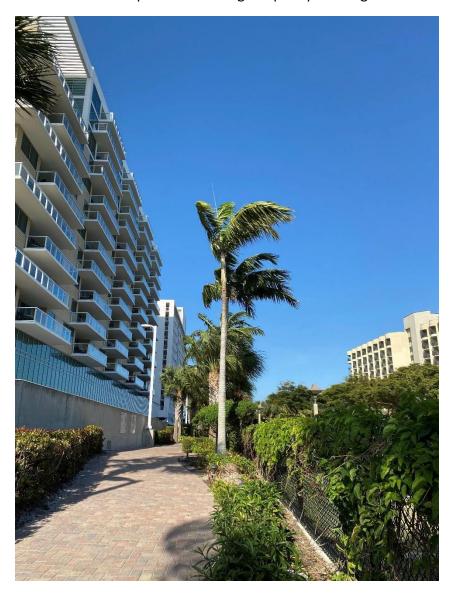
Palm trees: There are 35 medium-sized palm trees along the path providing intermittent shade.

Irrigation is installed but exposed along much of the path.
