Meeting Date: July 7, 2025 To: City Council From: Jeffrey E. Poteet, General Manager- Water & Sewer Through: Mike McNees, City Manager Re: Water and Sewer (W&S) Departmental Report

North Marco Main Improvements

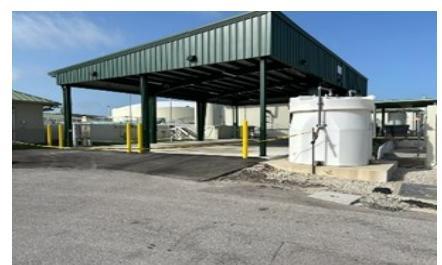
The construction of the Open Storage Structure is almost complete. The contractor is currently addressing the final punch list items and scheduling the final inspections. It remains on track to receive the certificate of occupancy in July.

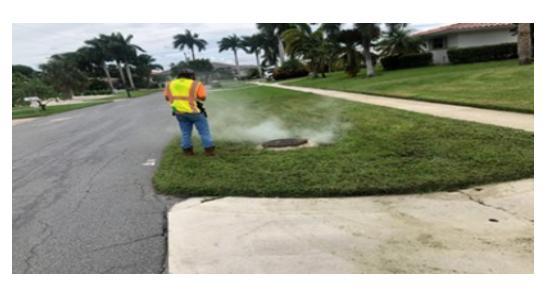
During testing, non-toxic, non-staining, and non-hazardous smoke is forced into sections of the sewer system using a high-powered fan inserted into an open manhole. If the system is functioning correctly, the smoke will travel through the sewer mains and escape through plumbing vents, typically seen exiting through rooftops.

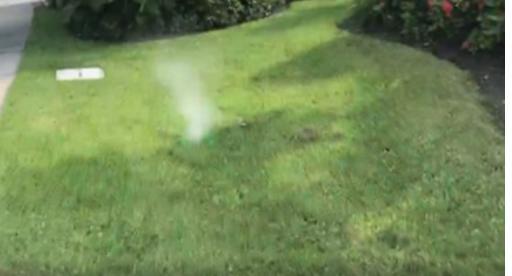
A sewer cleanout is a vital maintenance feature: a 6-inch vertical pipe connected to the lateral sewer line that links private properties to the public sewer system. Cleanouts are used for accessing the line during cleaning or removal of blockages.

Missing or broken cleanout caps are a common defect discovered during smoke testing. These defects are significant because they allow stormwater to enter the sewer system during rain events (inflow), and below-grade breaks can permit groundwater to infiltrate the system, both contributing to system overloading.

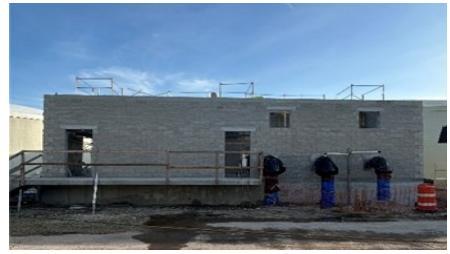
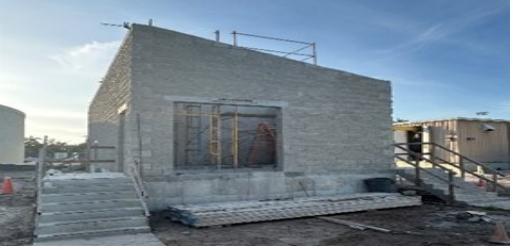
Construction of the walls for the Southwest Treatment Plant (SWTP) West High Service Pump

Station (HSPS) has been completed, following delays caused by the late delivery of the required split-face masonry blocks.
